**Date of Inspection: 8/25/2021**

## **Property Inspection Report**

**13737 US 23S, Ossineke, MI 49766**

**INSPECTOR: DUSTIN SAWMILLER**  
**FairWindsInspections@gmail.com**

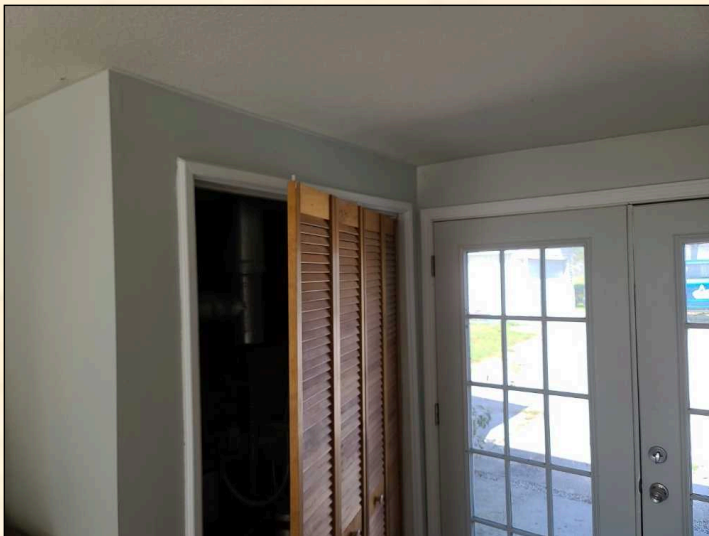
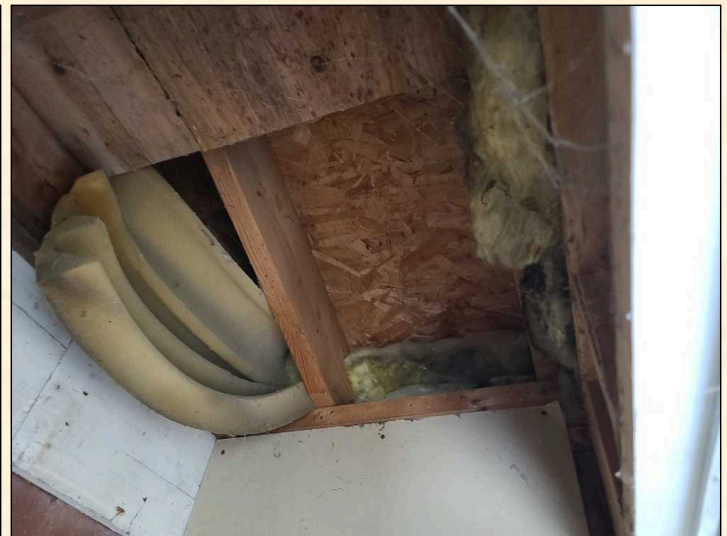
Closet door to boiler area is no longer on the track and appears to need new hardware for operation. Ceiling in closet is missing insulation and covering

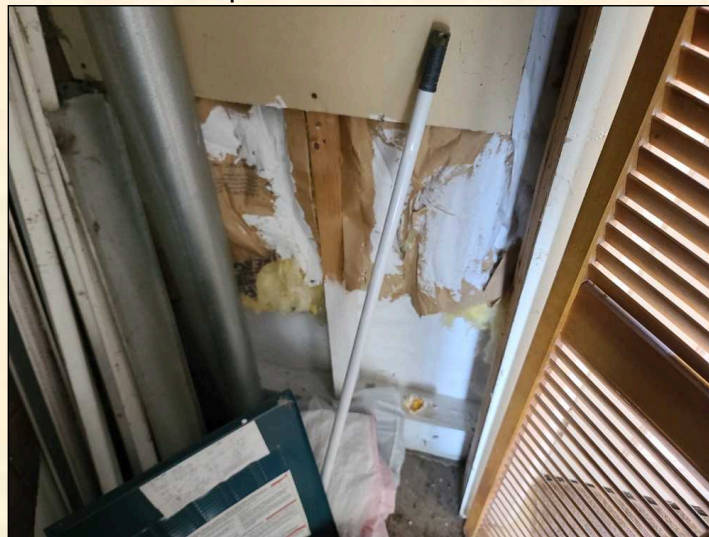
Missing drywall

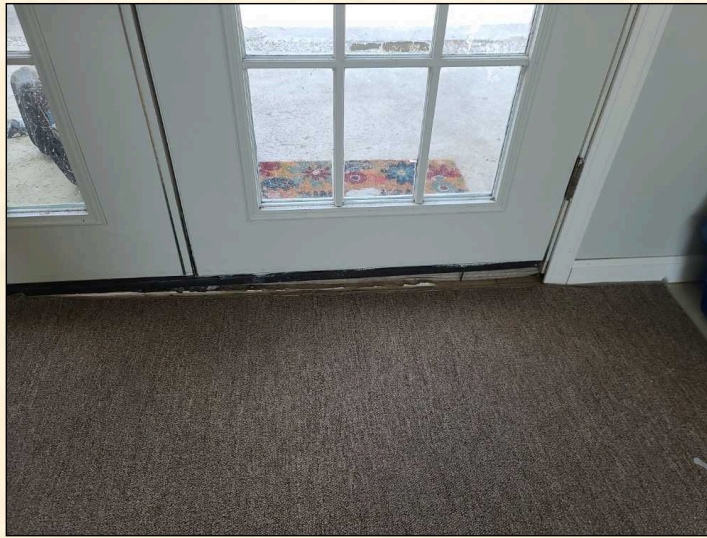
Moisture damage around the door trim

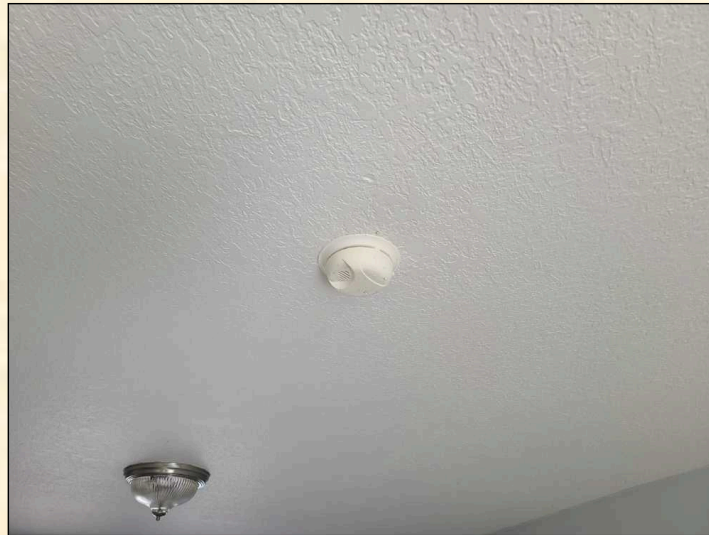
The smoke alarm(s) did not operate when tested.

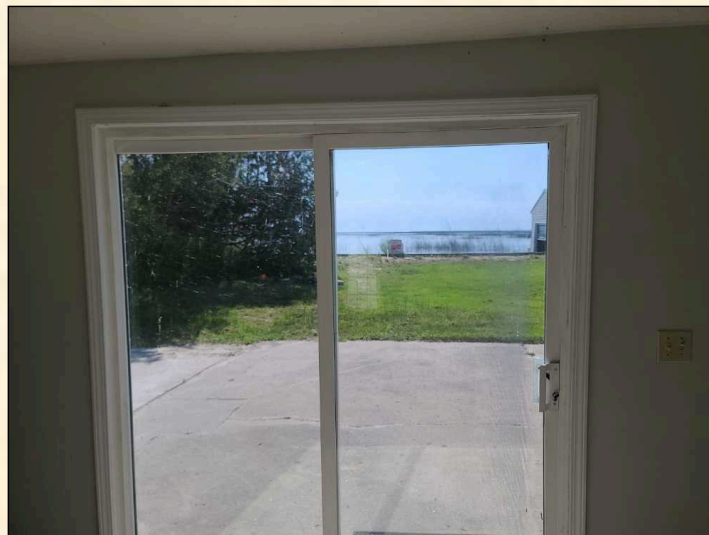
Sliding door screen is missing.

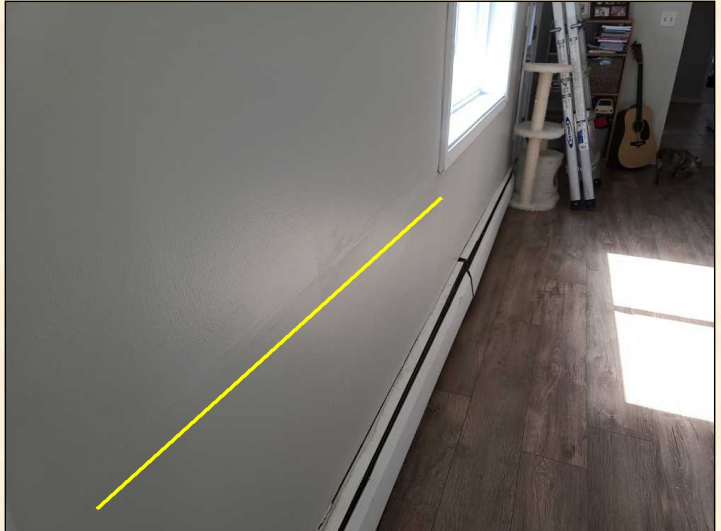
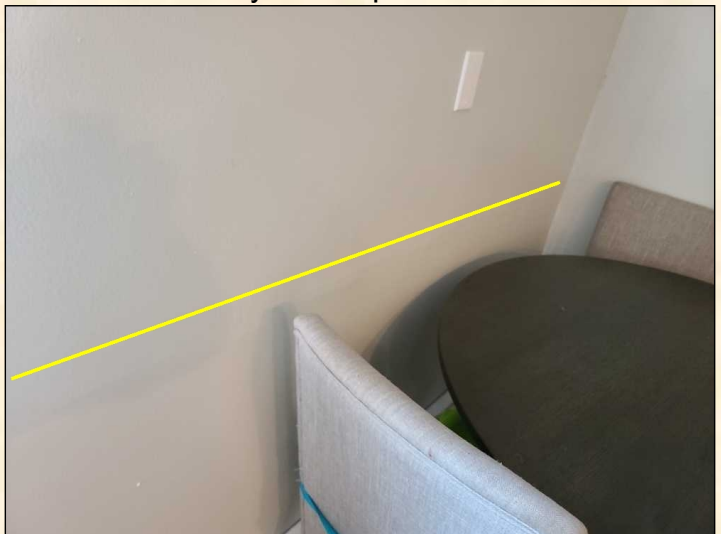
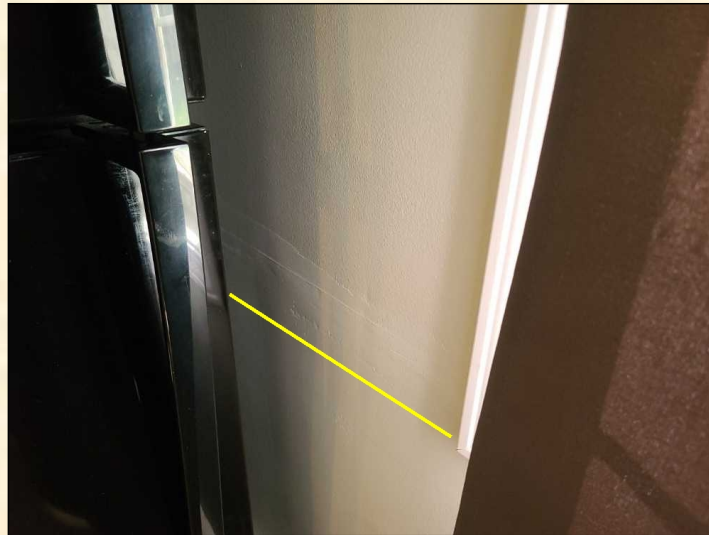
There were signs of past water damage to drywall; however, no active moisture was detected during the inspection. The installation appeared to be less than professional and the insulation behind the drywall is questionable.

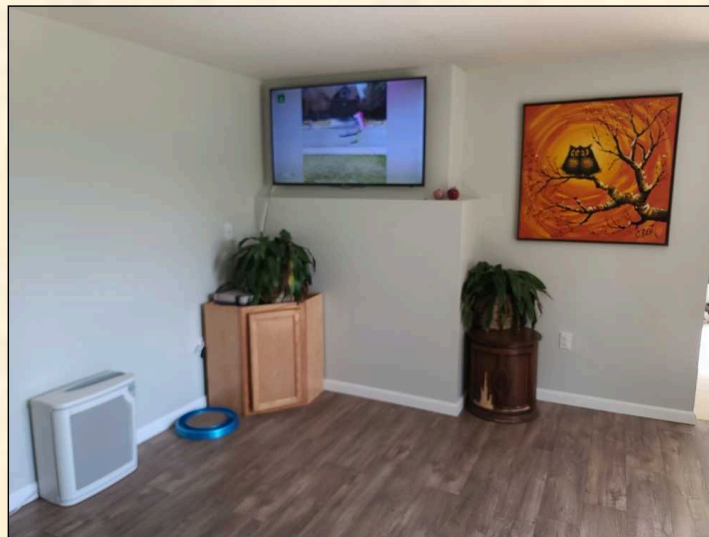
Fireplace has been drywalled over.

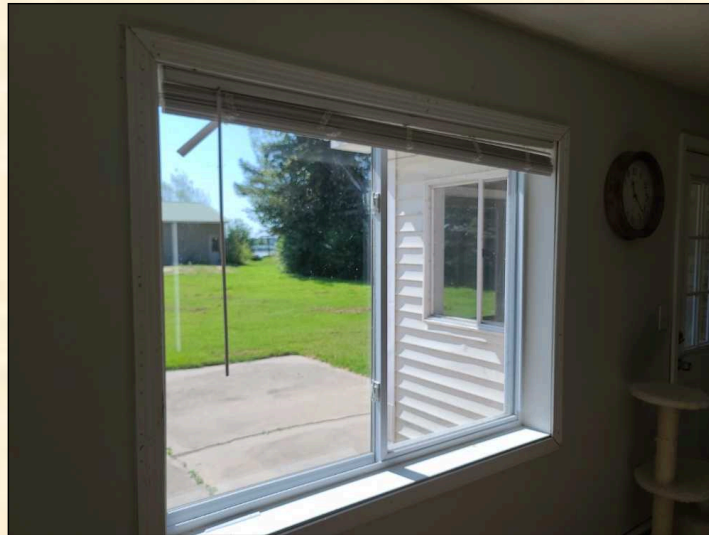
Missing screens observed.

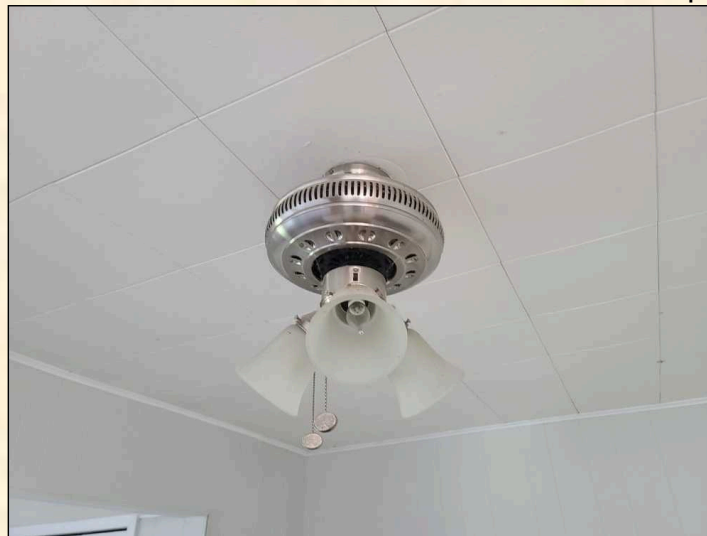
The ceiling fan is missing blades, generic replacement blades are available at your local home improvement center.

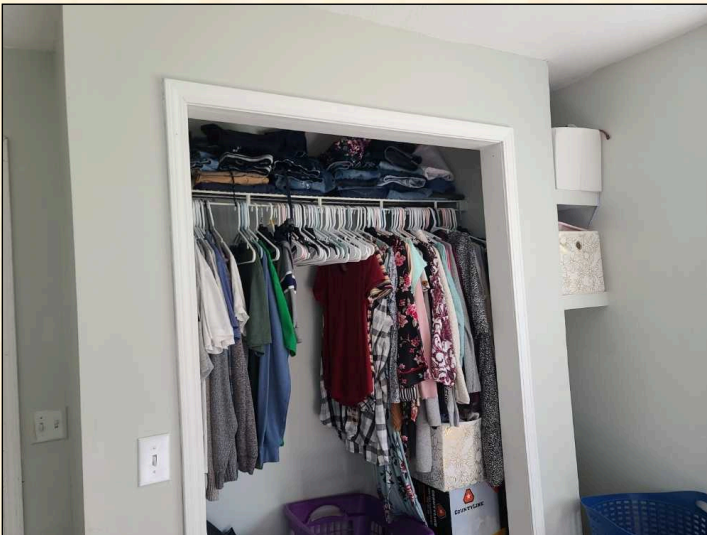
The closet door was missing.

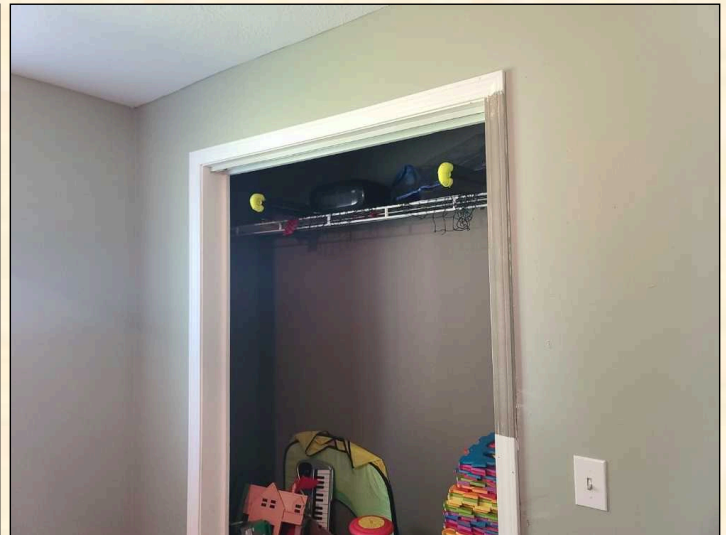
The closet door was missing.

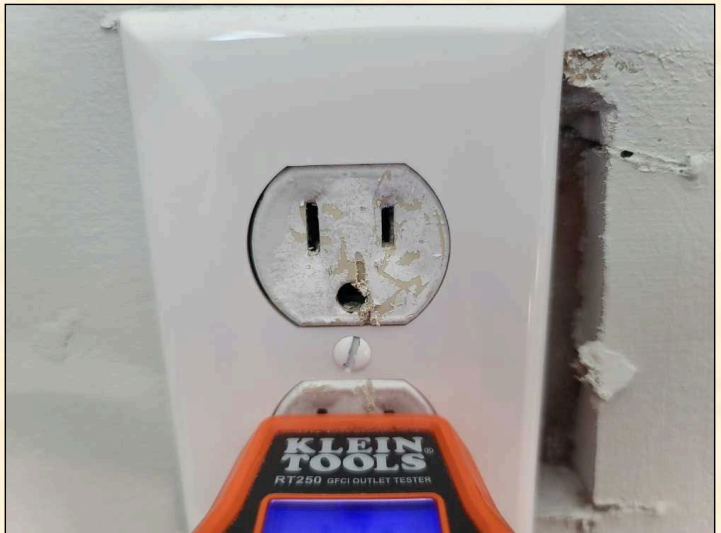
Some receptacles were painted over.

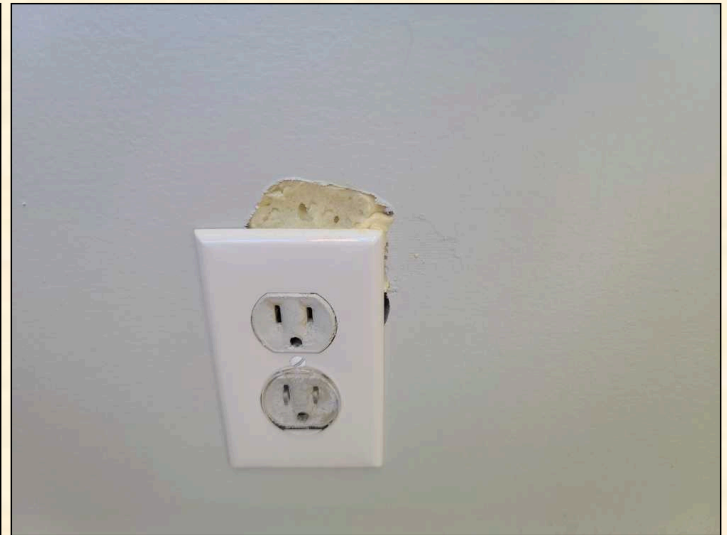
Gap around Outlet observed.

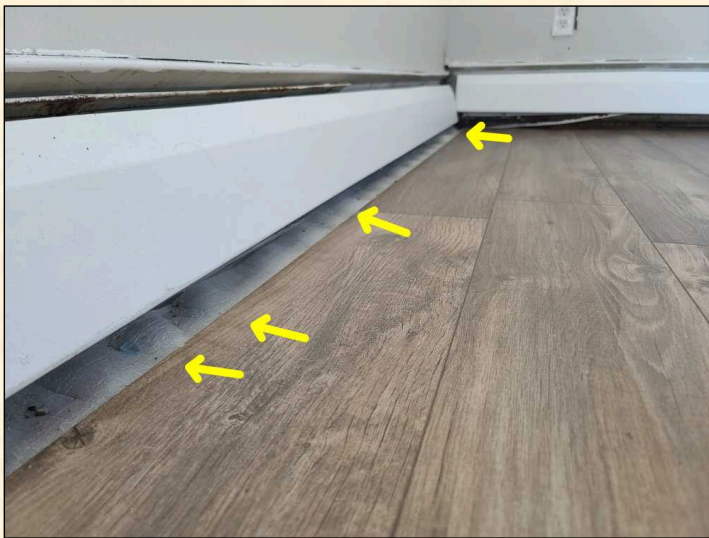
Open seams/partially finished flooring observed.

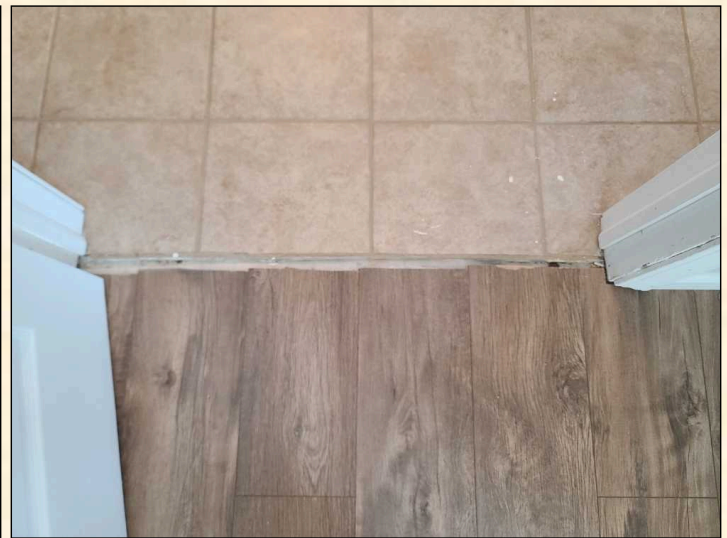
Open seams/partially finished flooring observed.

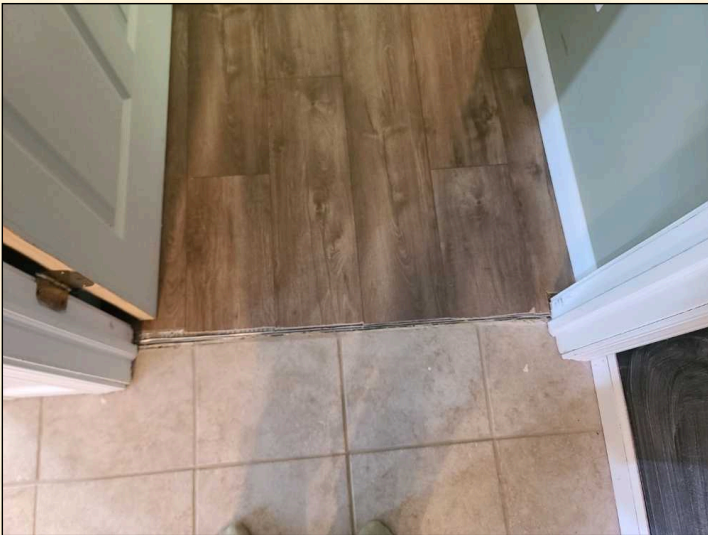
Open seams/partially finished flooring observed.

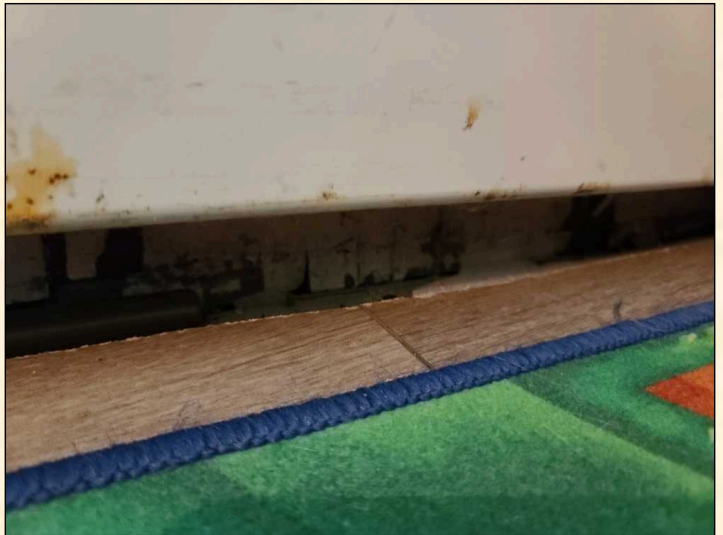
Open seams/partially finished flooring observed.

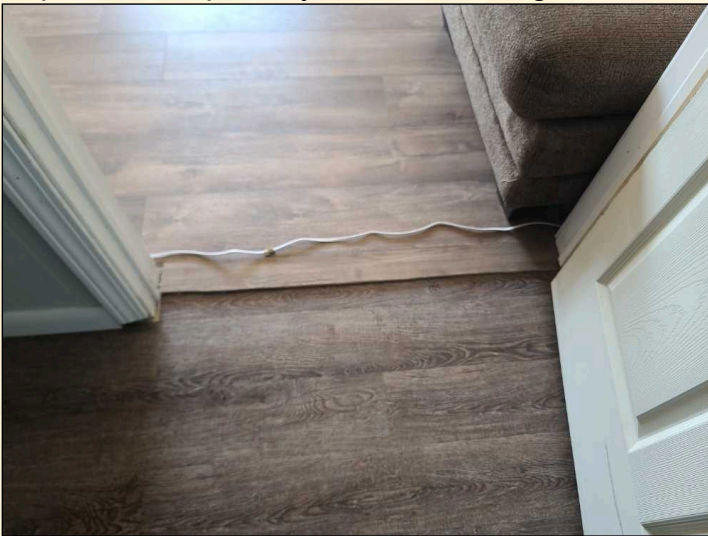
Open seams/partially finished flooring observed.

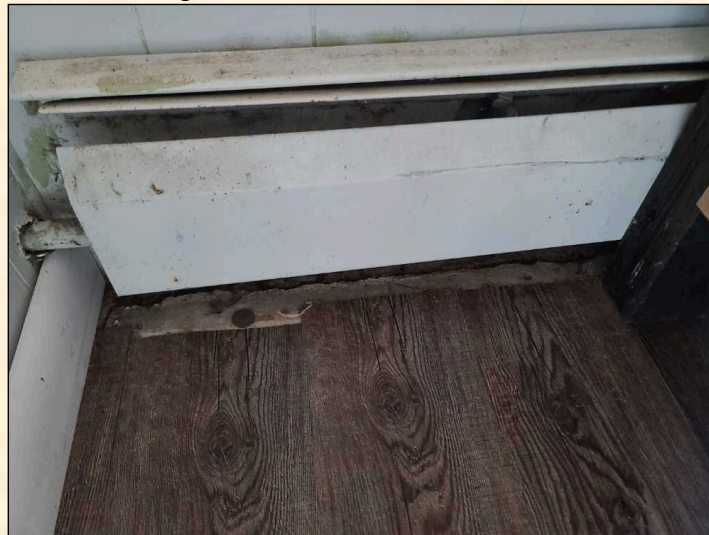
Open seams/partially finished flooring observed.

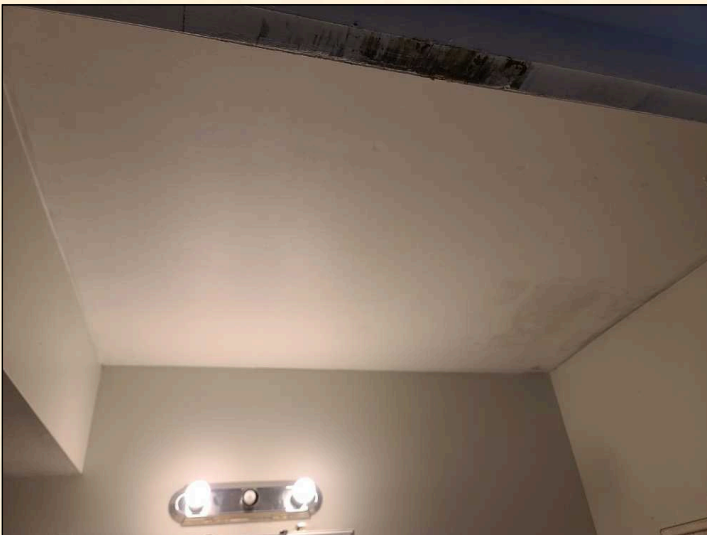
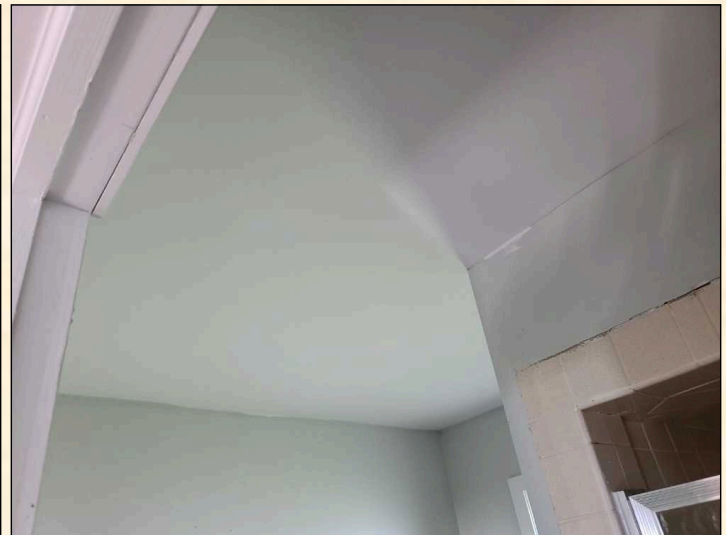
No fan was observed, we recommend an exhaust fan be installed in all bathrooms for proper ventilation and moisture control.

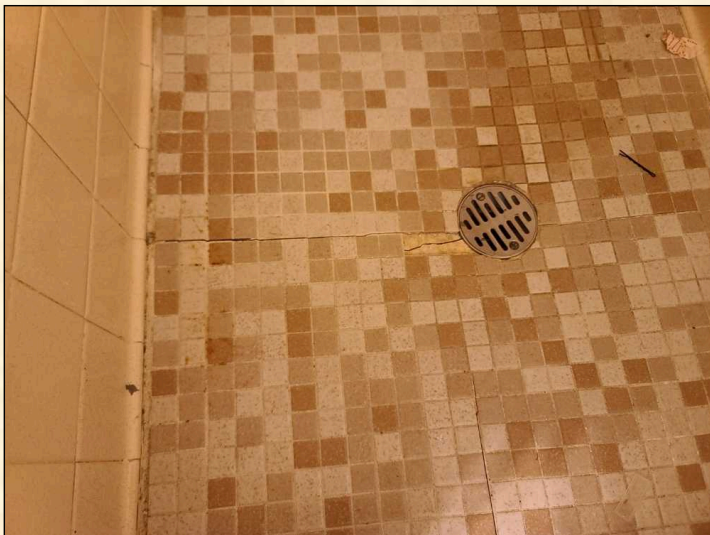
Tile base is cracked.

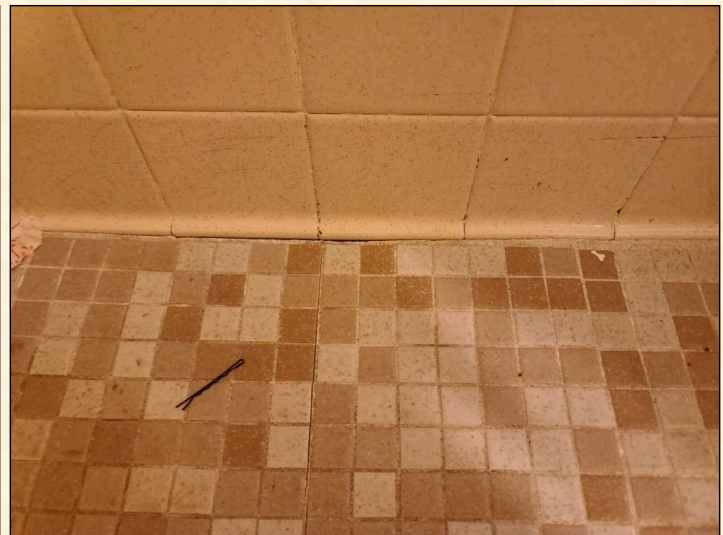
Gap in grout noted at tile. Recommend maintenance of grout and caulking to prevent water seepage.

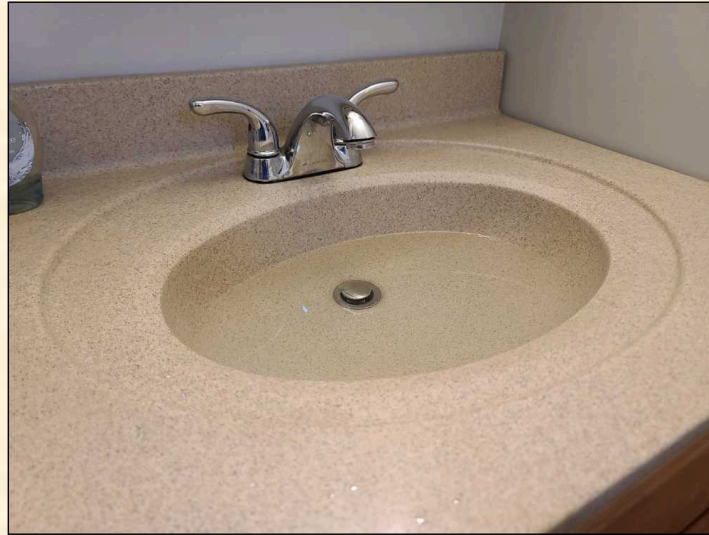
Slow drain at sink. Recommend clearing.

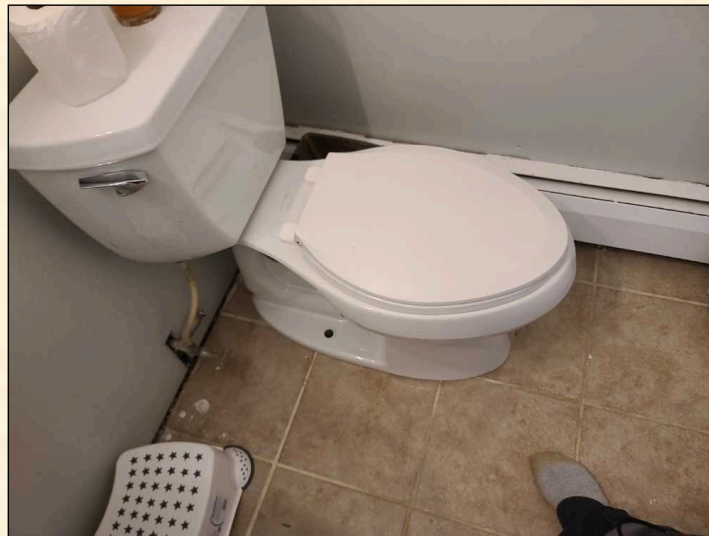
Toilet loose and may need re-anchoring.

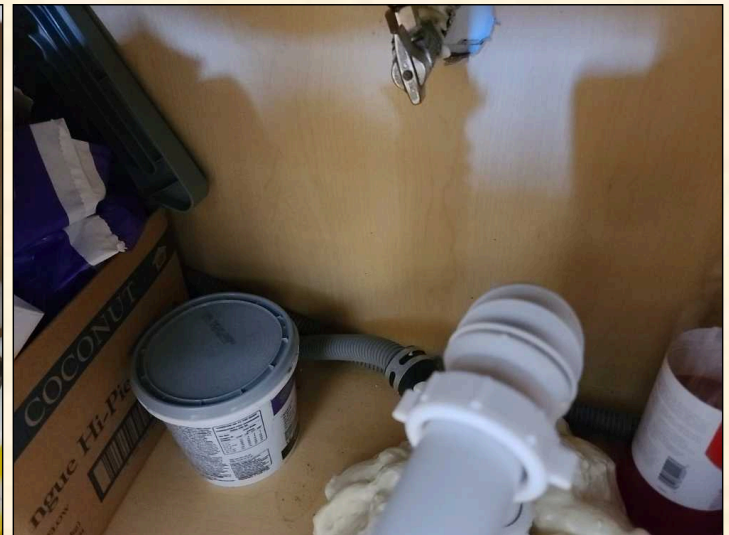
Dishwasher is draining downstream of the trap. This is an improper location and cannot ensure that sewer gases do not enter the appliance.

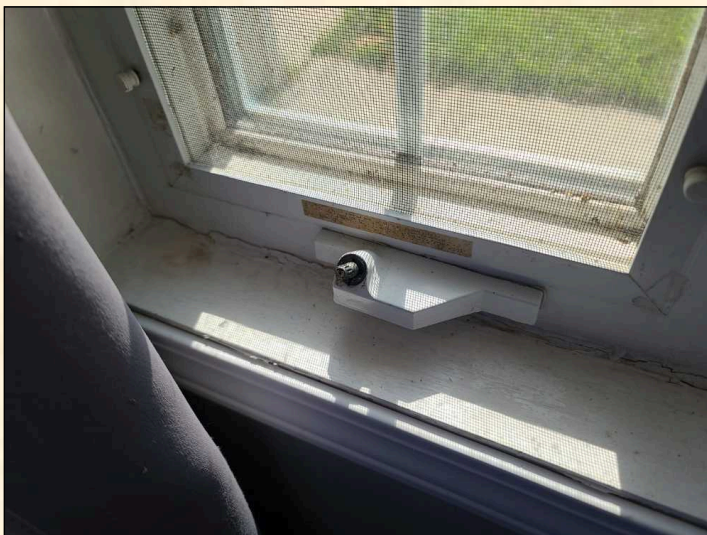
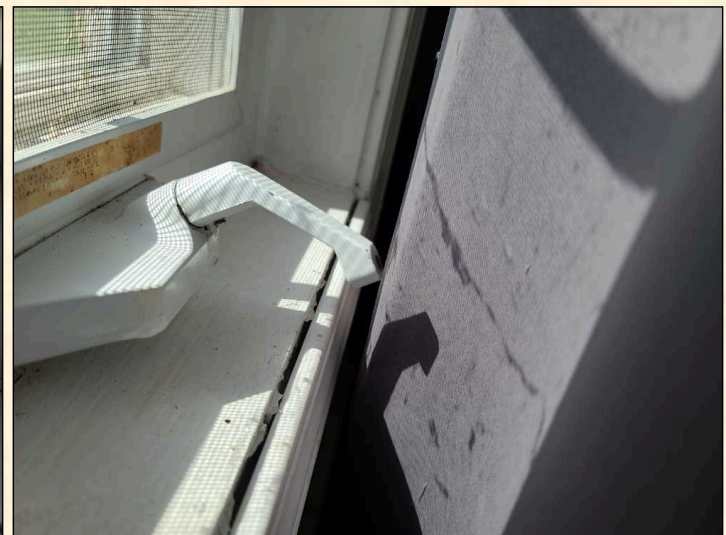
Missing hardware at the kitchen windows. Repair as needed.

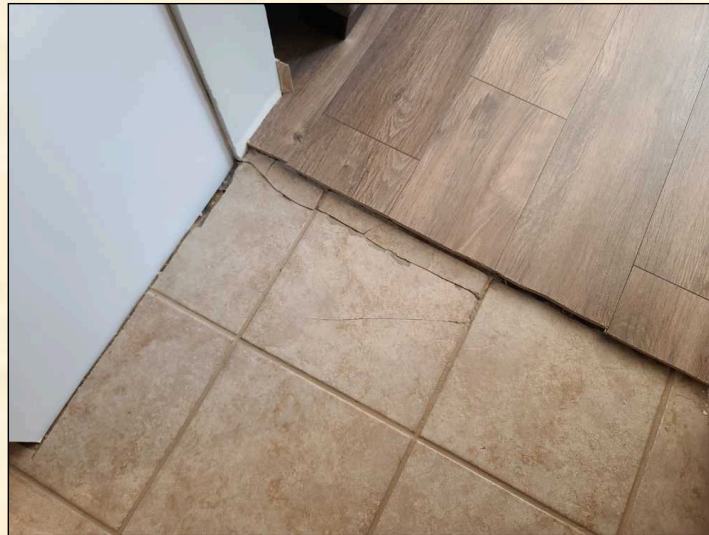
Cracked tiles noted.

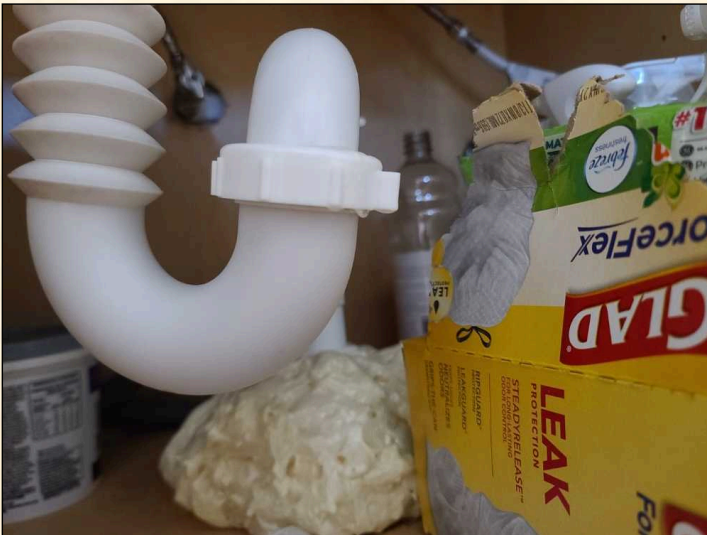
Sink drain assembly is loose. Leaks observed.

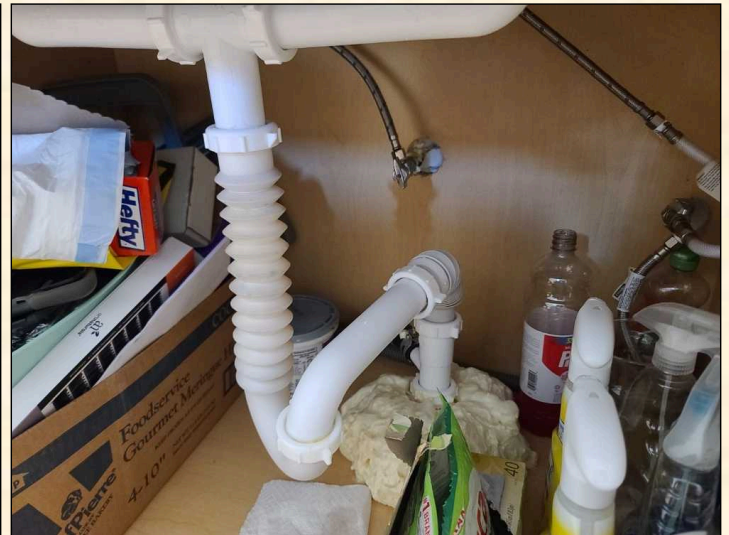
Flex drain observed, these are subject to frequent clogging.

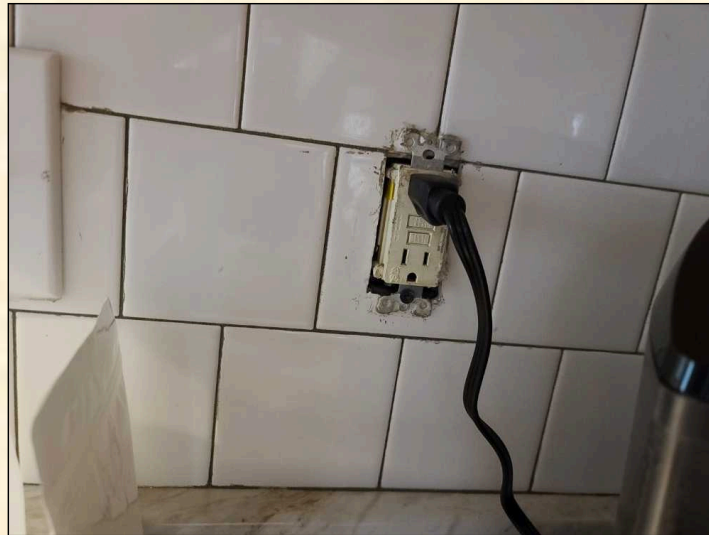
Outlet cover(s) missing.

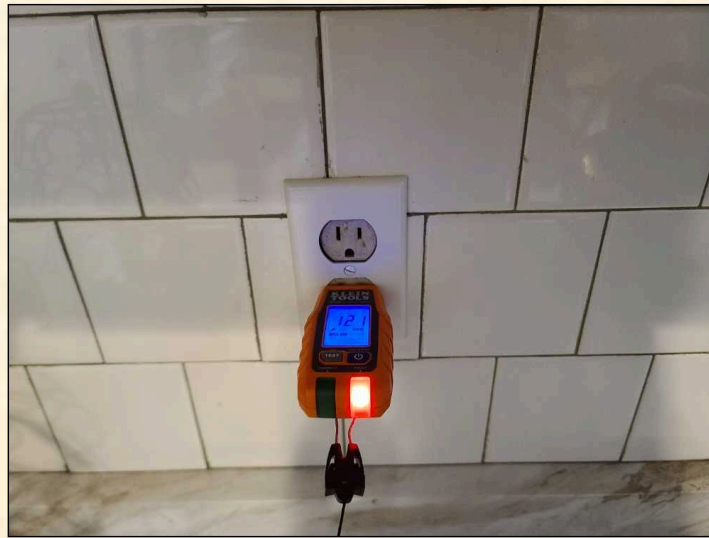
Non GFCI receptacle noted at the countertop.

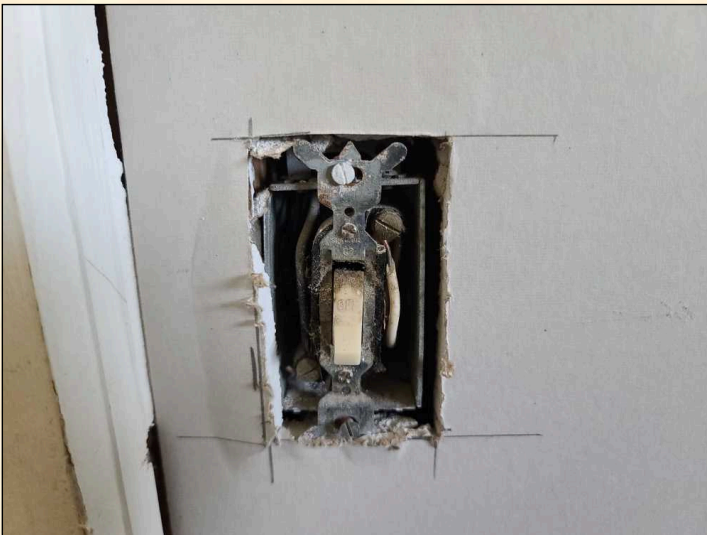
Switch cover plates missing.

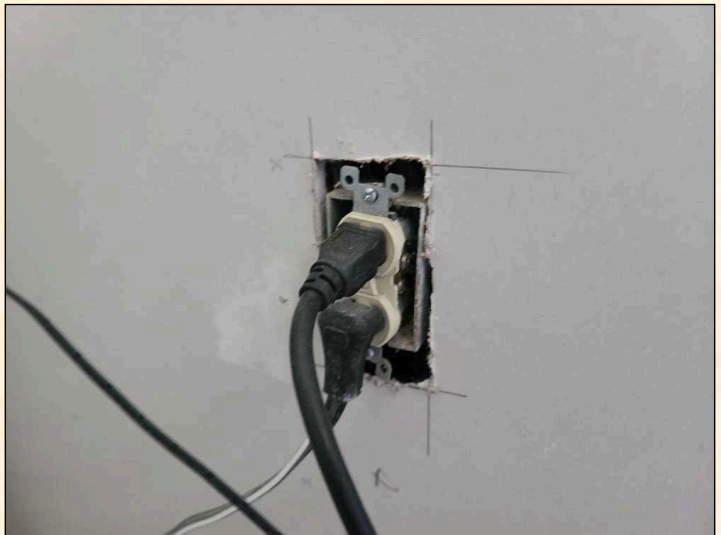
Outlet cover plates missing.

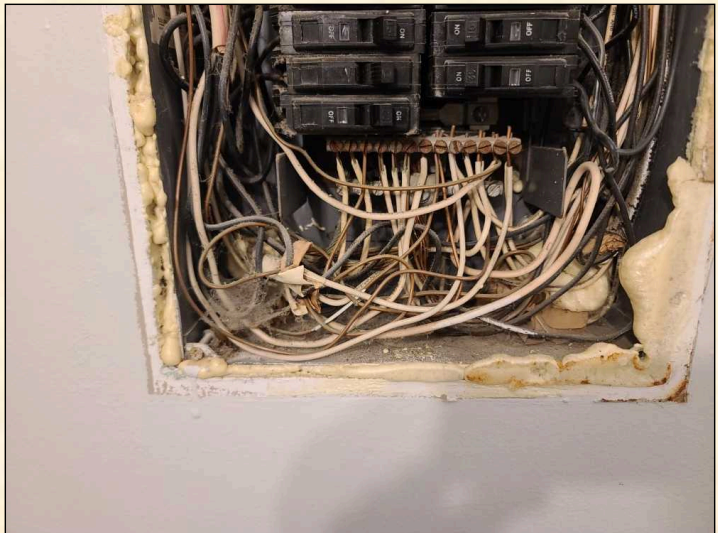
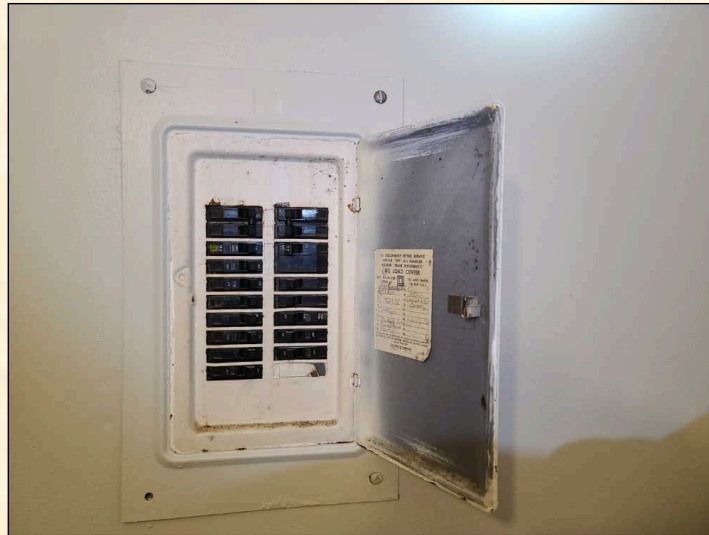
Panel is located in the bathroom. This is not an acceptable location for the panel as it is exposed to high levels of moisture.

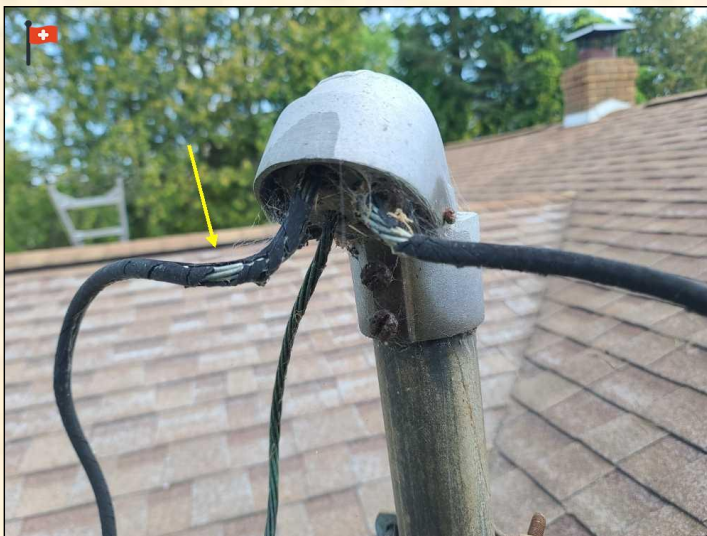
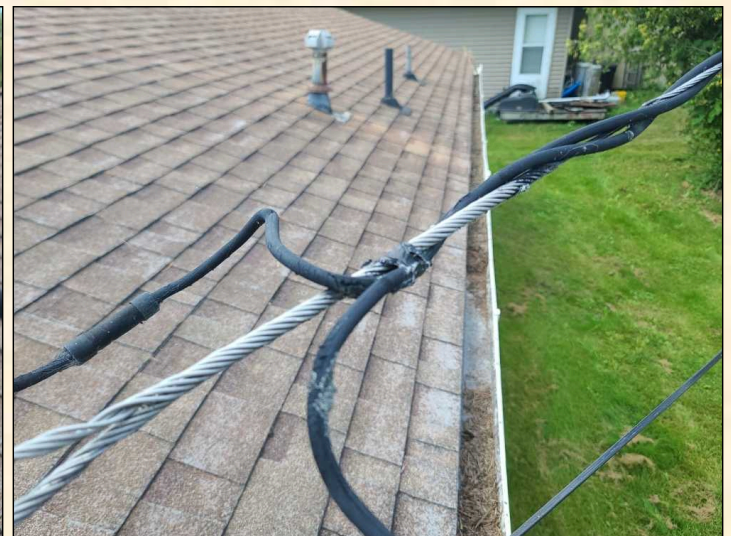
Bare conductors observed. Recommend review by a licensed electrician for repair or replacement, as necessary, prior to close.

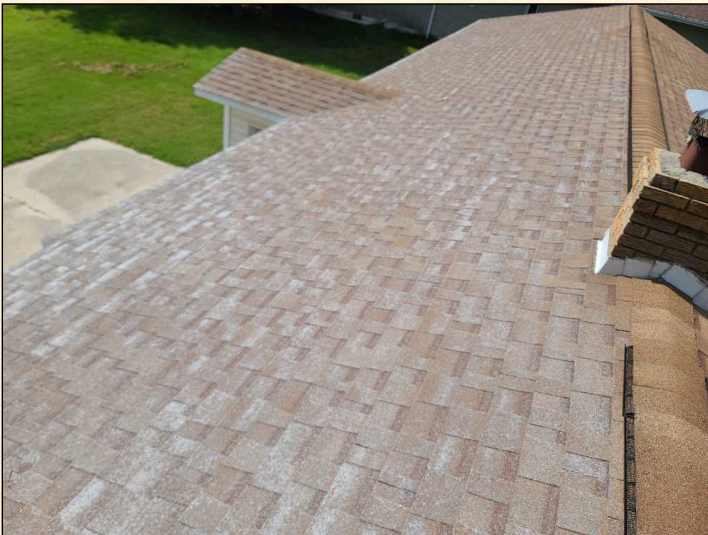
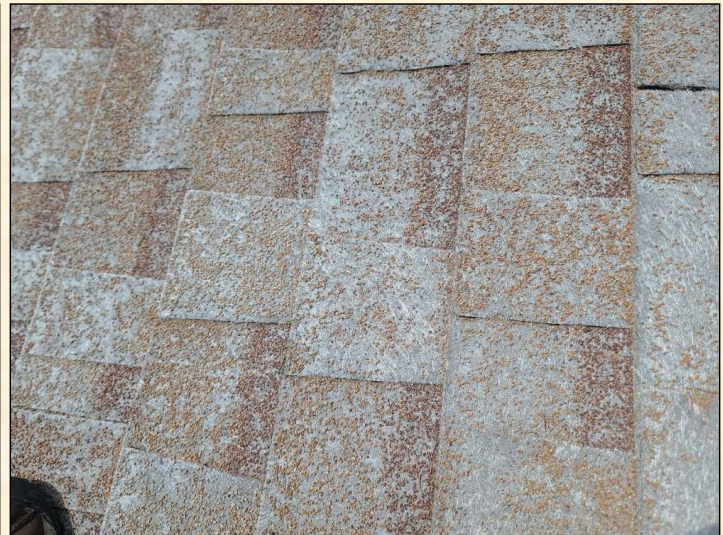
Extensive granular lost noted with numerous tabs having almost complete granular loss.

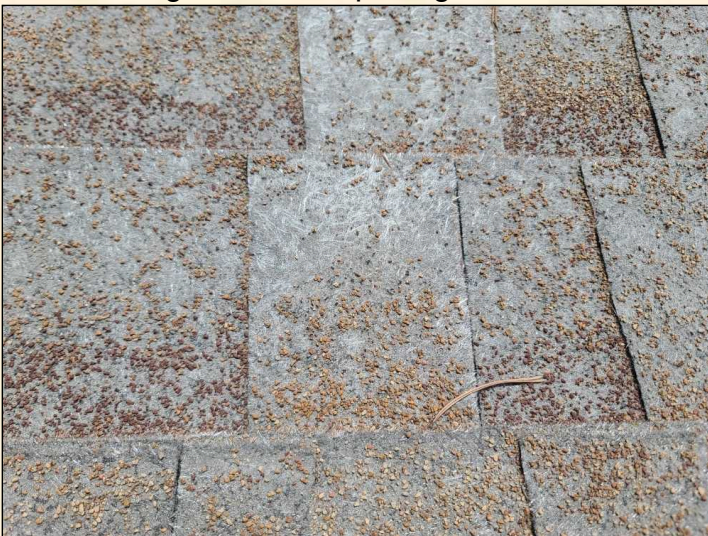
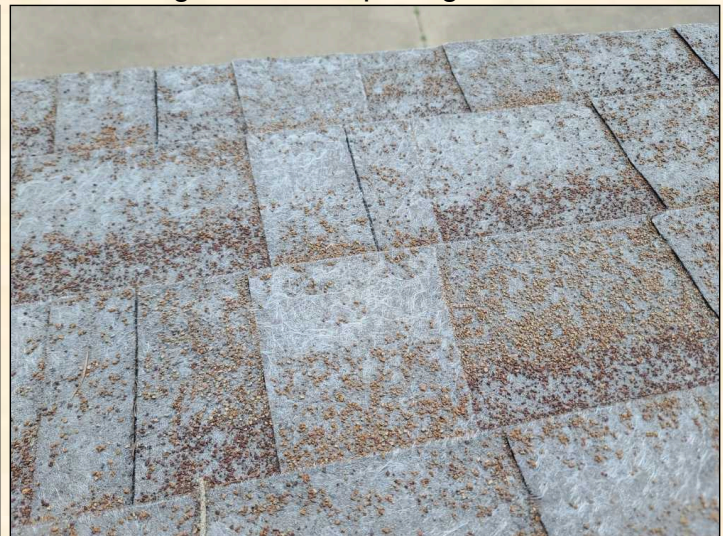
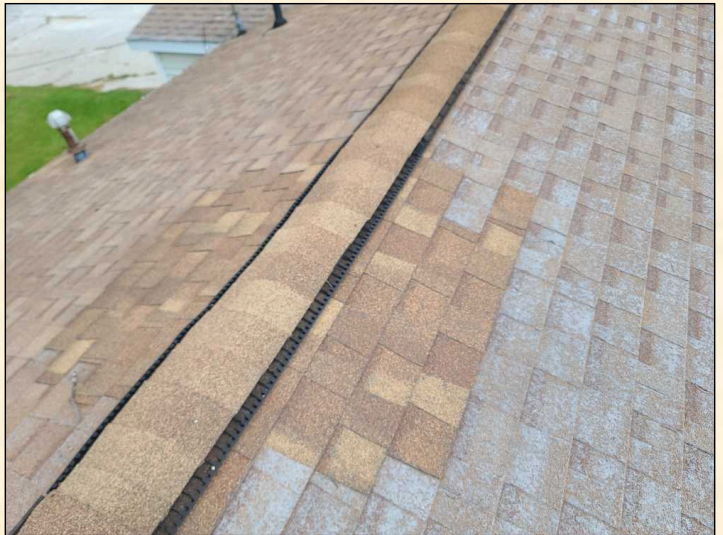
Serviceability of roof is questionable; it should be evaluated and repaired as necessary by a professional roofing contractor.

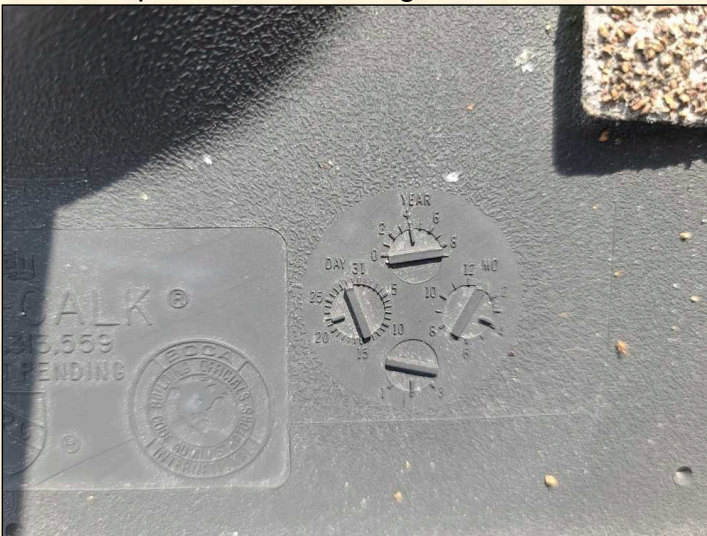
Vent boots from 2004. Estimated roof age

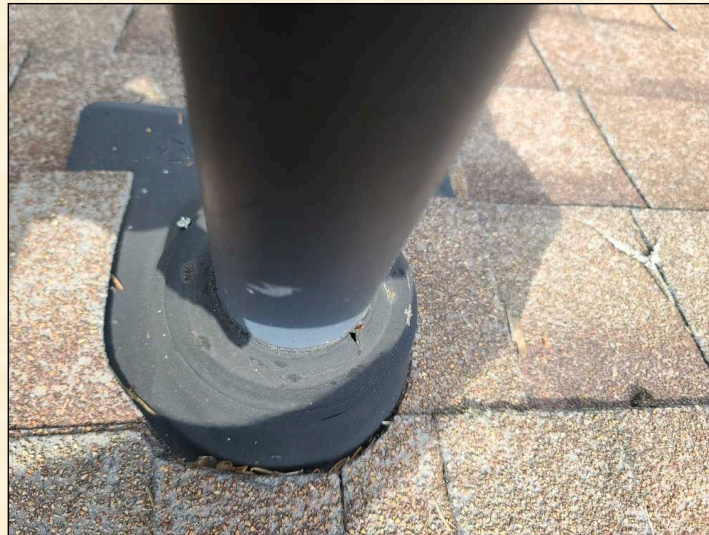
One vent boot needs to be resealed or replaced.

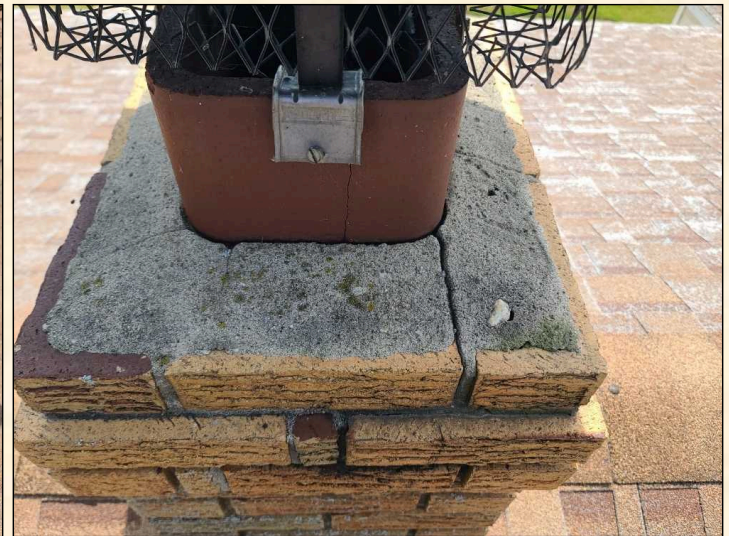
Brick and mortar deterioration observed; repair advised.

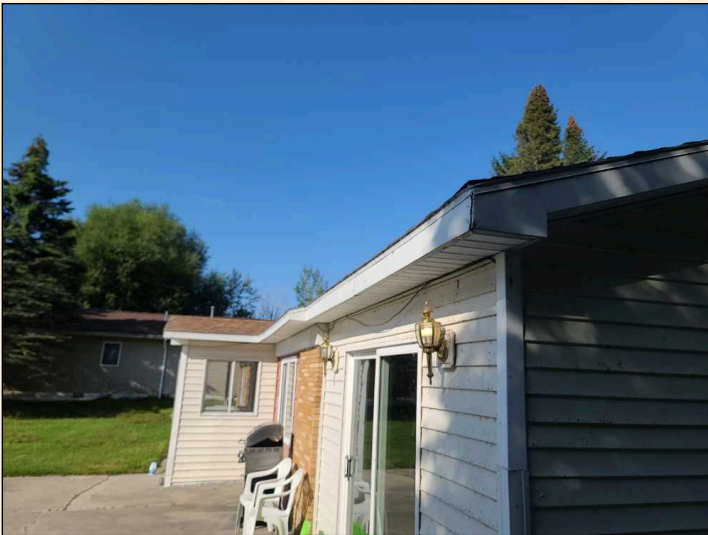
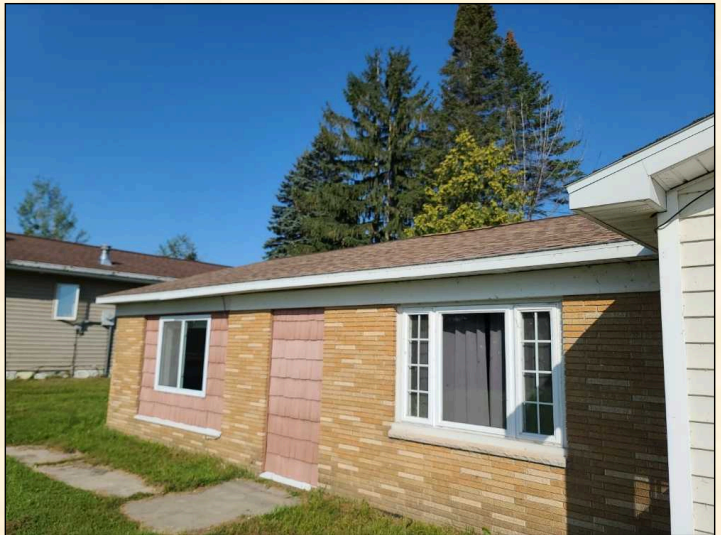
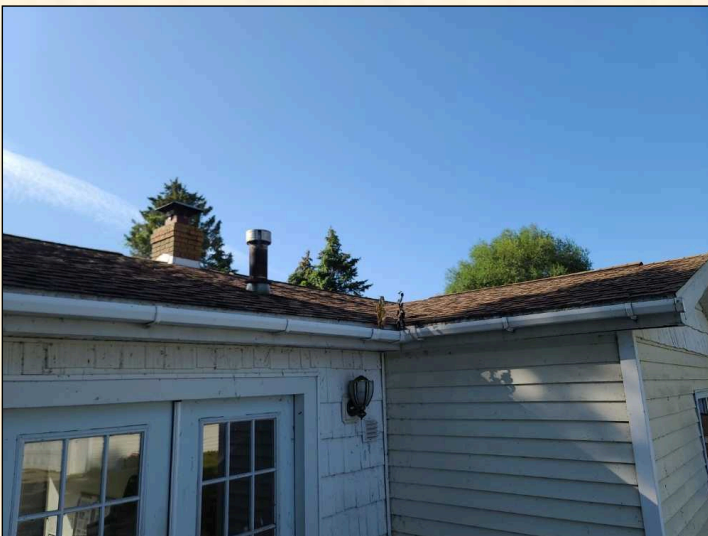
Partial gutters - Full installation recommended to keep water away from structure. Water can weaken the foundation and deteriorate the siding. Be sure to install splashblocks or extensions to carry water away, and keep water from areas such as driveways or walks where it can be an ice hazard in winter.

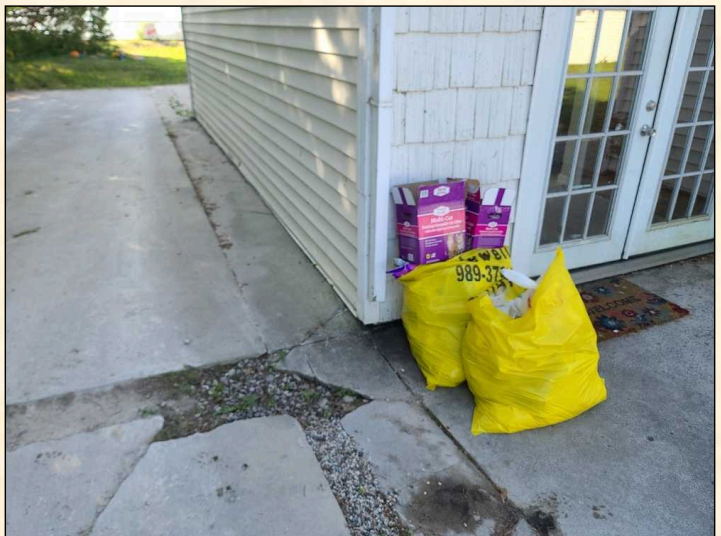
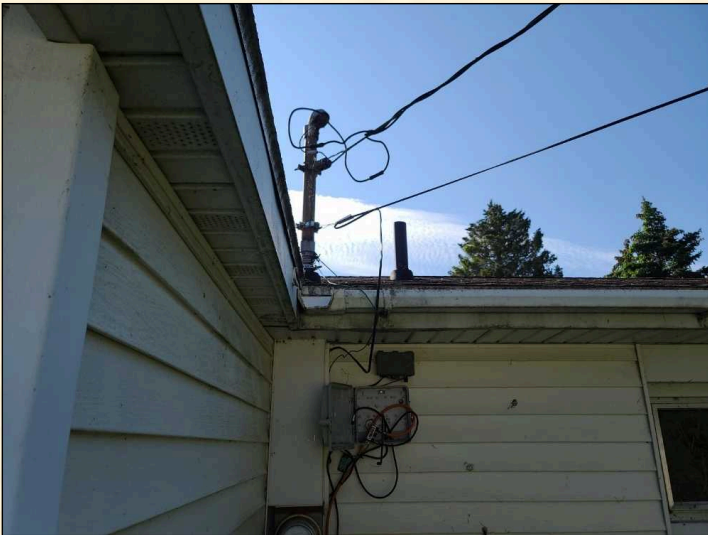
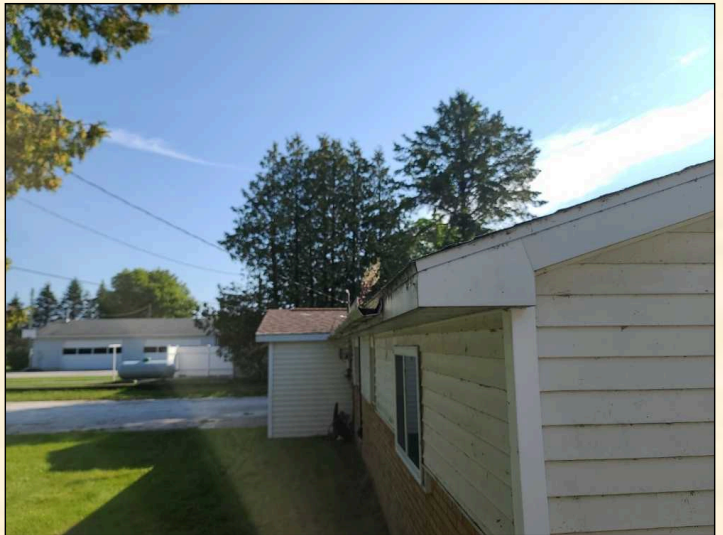
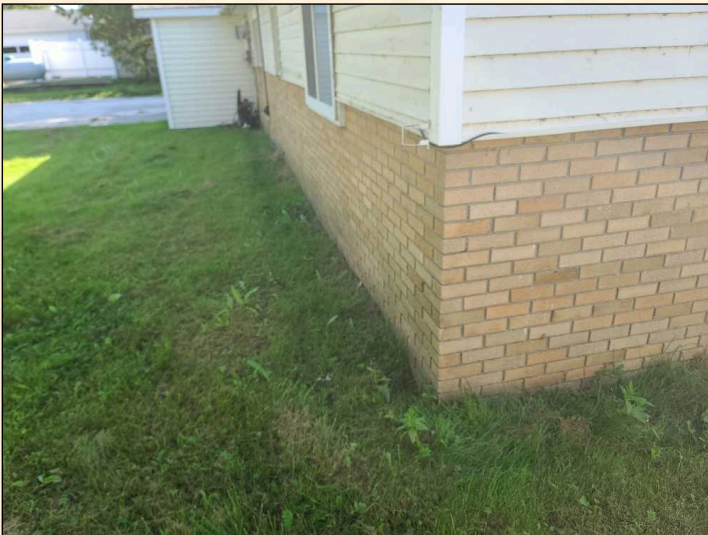
Downspouts missing and/ or broken; recommend installation.

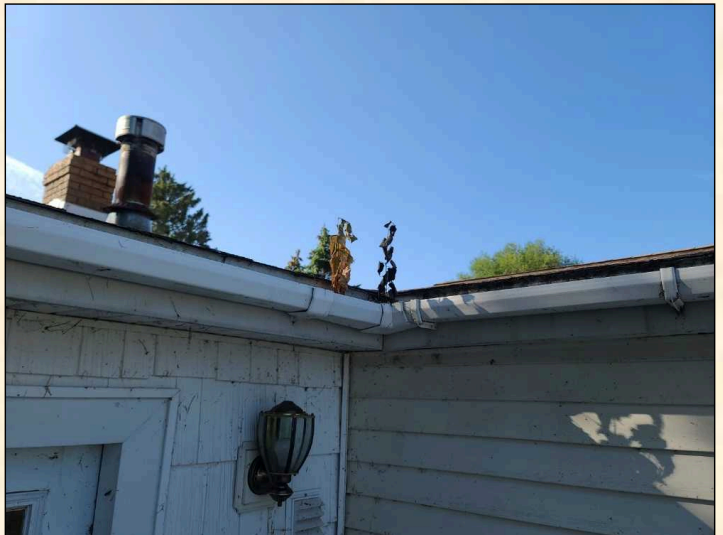
Clean gutters: Significant amounts of debris evident.
