**Date of Inspection: 8/25/2021**

## **Property Inspection Report**

**13737 US 23S, Ossineke, MI 49766**

**INSPECTOR: DUSTIN SAWMILLER**  
**FairWindsInspections@gmail.com**

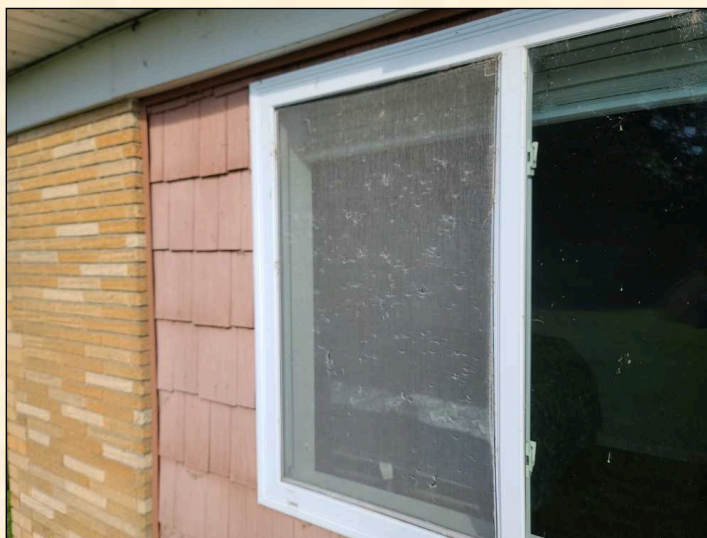
Some window screens damaged.

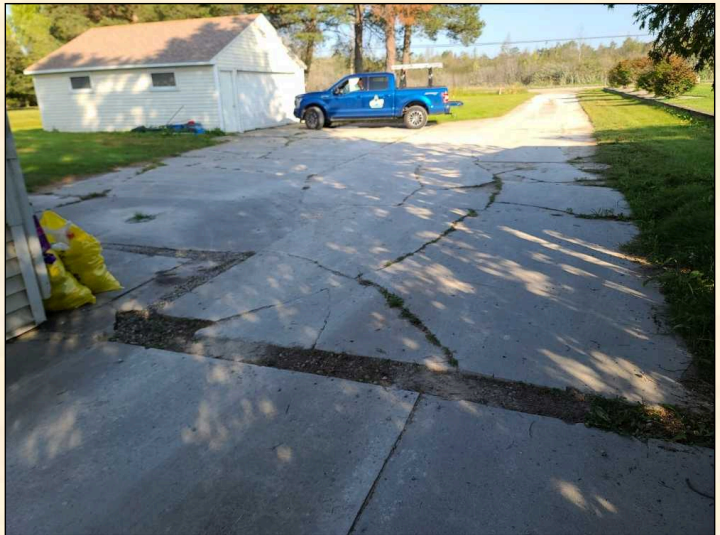
There are numerous areas of damaged concrete surfaces. Concrete replacement is expensive. Recommend a concrete specialist provide an estimate for repair and or replacing.

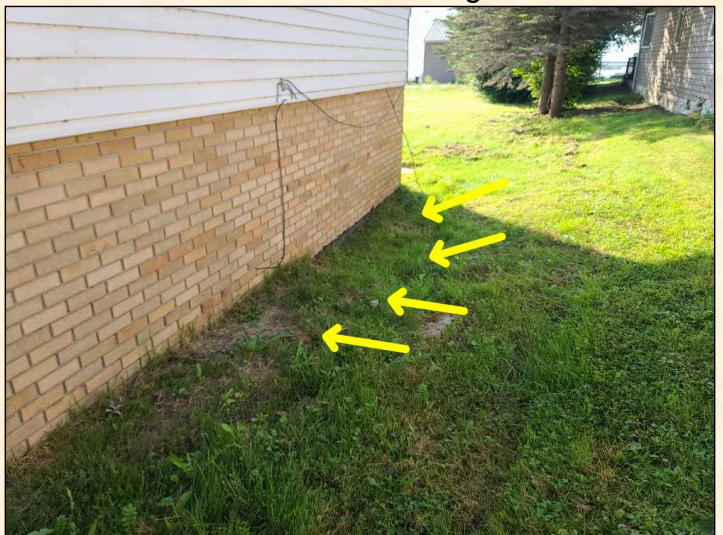
Low and settled grading was observed along the Northwestern (front) and Southwestern (side) areas of the home. Water can intrude affect the foundation.
