**Date of Inspection: 8/25/2021**

## **Property Inspection Report**

**13737 US 23S, Ossineke, MI 49766**

**INSPECTOR: DUSTIN SAWMILLER**  
**FairWindsInspections@gmail.com**

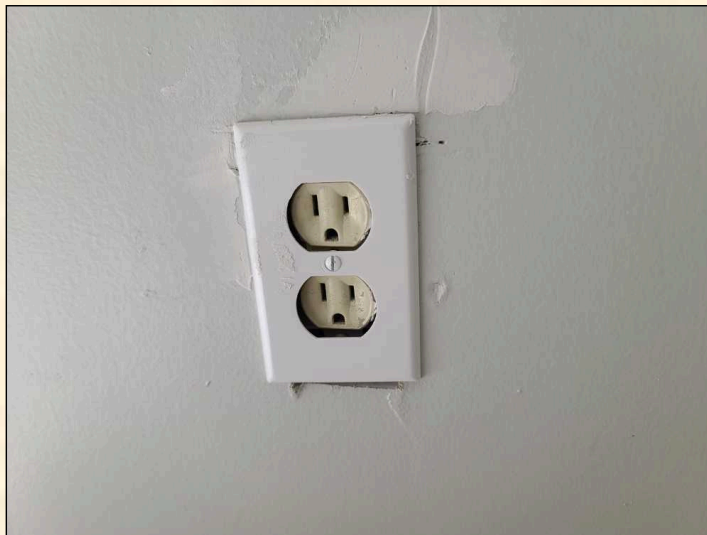
Outlet is recessed in the cover and should be installed properly for safety and functionality

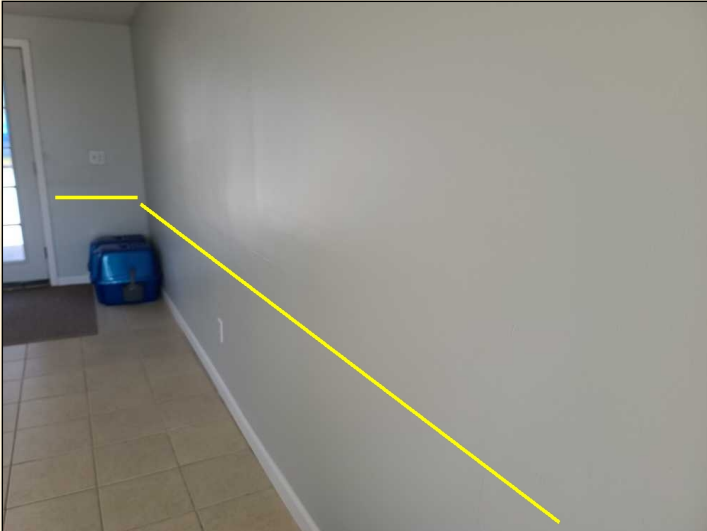
Interior Areas Wall Condition

- There were signs of past water damage to drywall; however, no active moisture was detected during the inspection. The installation appeared to be less than professional and the insulation behind the drywall is questionable.

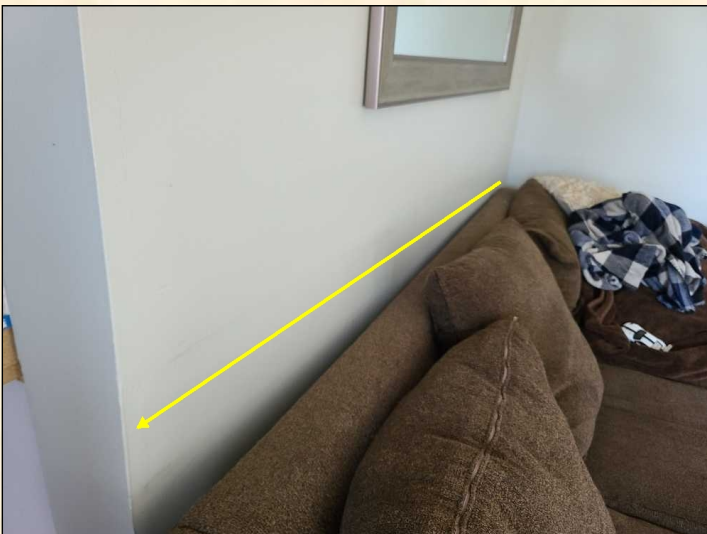
Interior Areas Wall Condition

There were signs of past water damage to drywall; however, no active moisture was detected during the inspection. The installation appeared to be less than professional and the insulation behind the drywall is questionable.

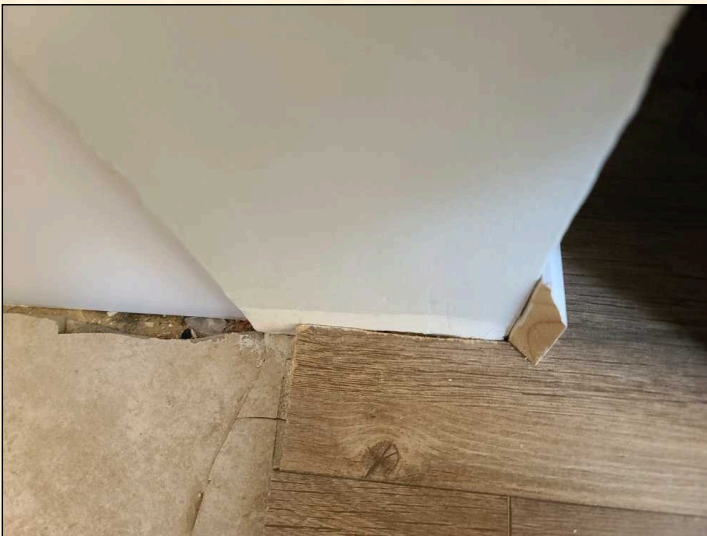
Interior Areas Floors

- Laminate floating floor system was installed with poor workmanship techniques, gaps, under size cuts, and chips are visible giving a less than appealing appearance and likely lowering the serviceable life of the flooring

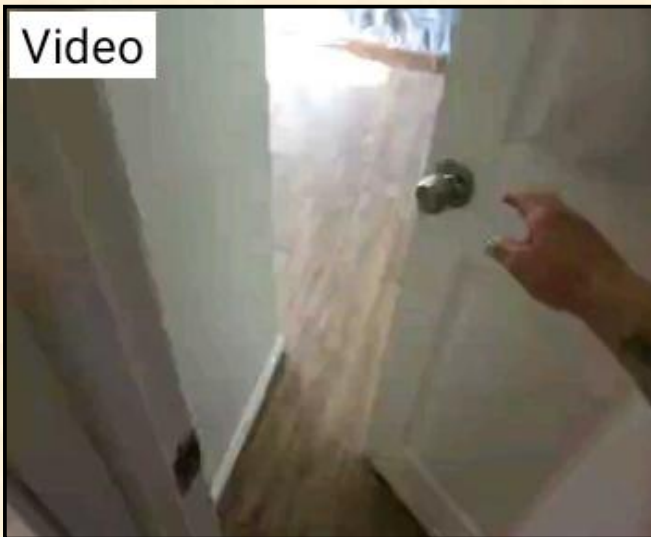
SW bedroom (2&3) doors bind in the jam.

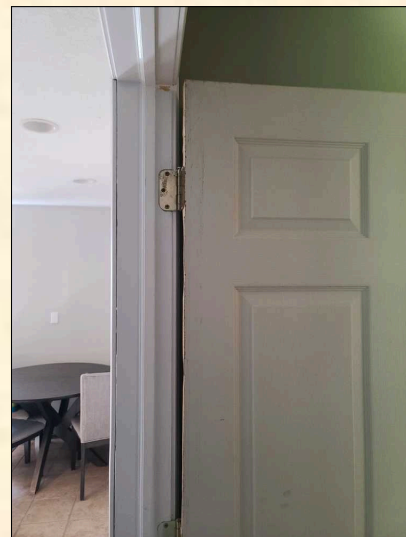
Non-professional cutting of the doors, could be contributing to the jamming.

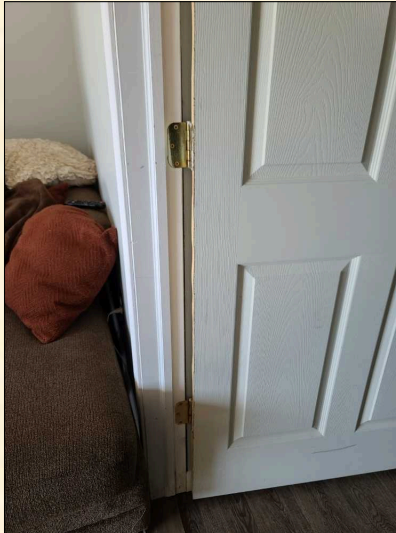
Non-professional cutting of the doors, could be contributing to the jamming.

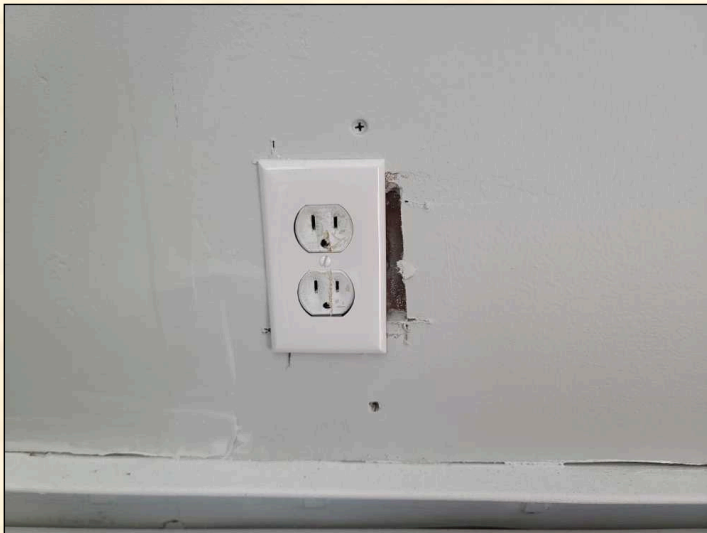
Gap around Outlet observed.

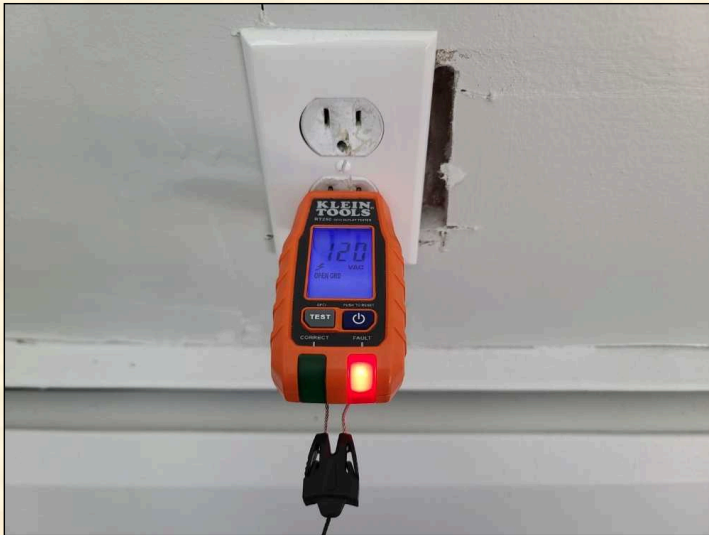
Open ground (or 2-wire) outlets present. This means that the 3rd (round) part of an appliance plug is not getting ground protection.

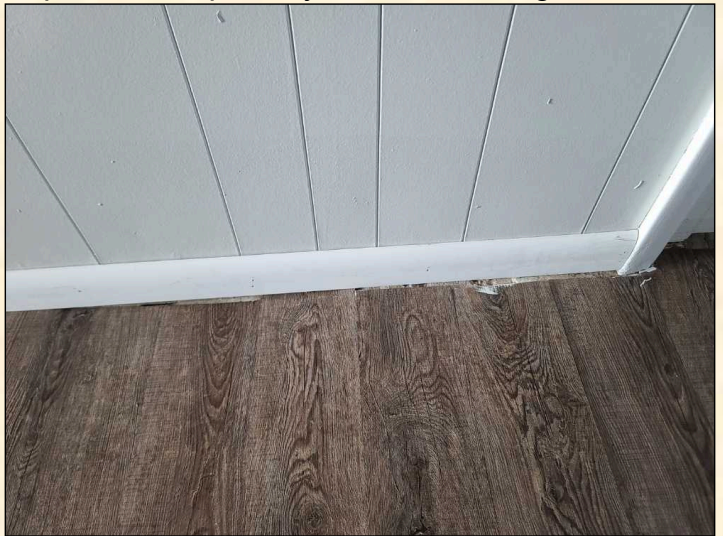
Bedrooms Floor Condition

- Open seams/partially finished flooring observed.
- Laminate floating floor system was installed with poor workmanship techniques, gaps, under size cuts, and chips are visible giving a less than appealing appearance and likely lowering the serviceable life of the flooring

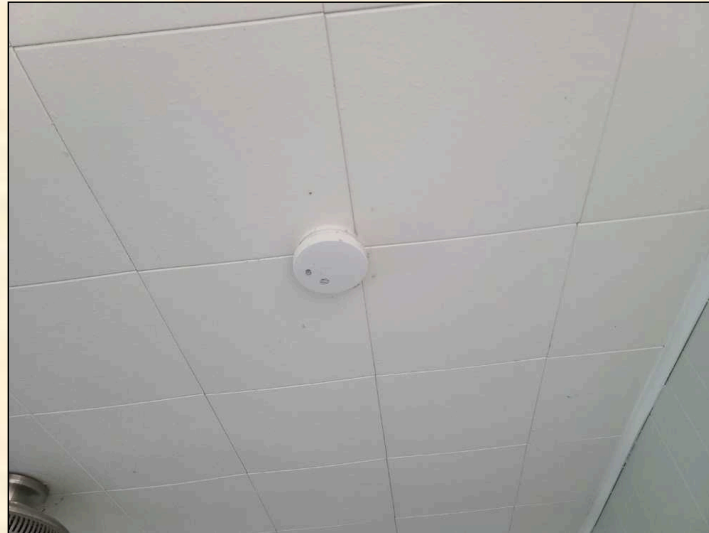
The smoke detectors did not operate during the inspection.

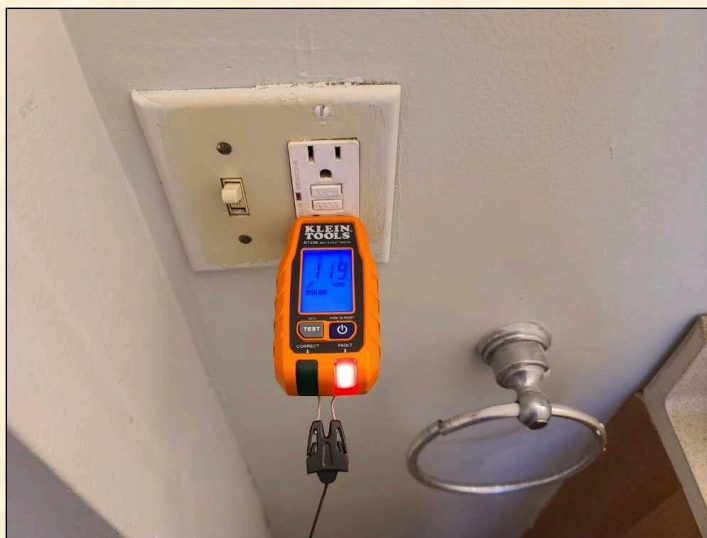
Open ground (or 2-wire) outlets present. This means that the 3rd (round) part of an appliance plug is not getting ground protection.

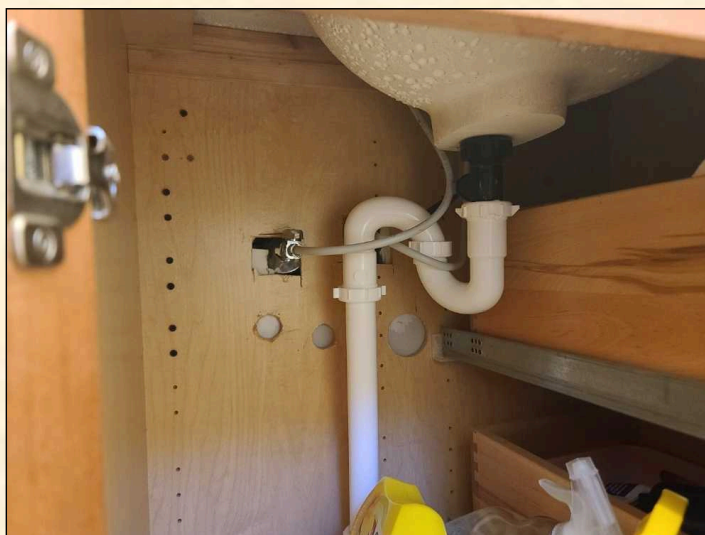
Improper "S" trap noted. This trap configuration may cause the trap to siphon dry, allowing sewer gas and odour to enter the dwelling. This situation may be rectified by the installation of an anti siphon device (cheater vent). Suggest repair by a qualified professional. In the alternative, run a little bit of water into the sink to reseal the trap if odour is detected.

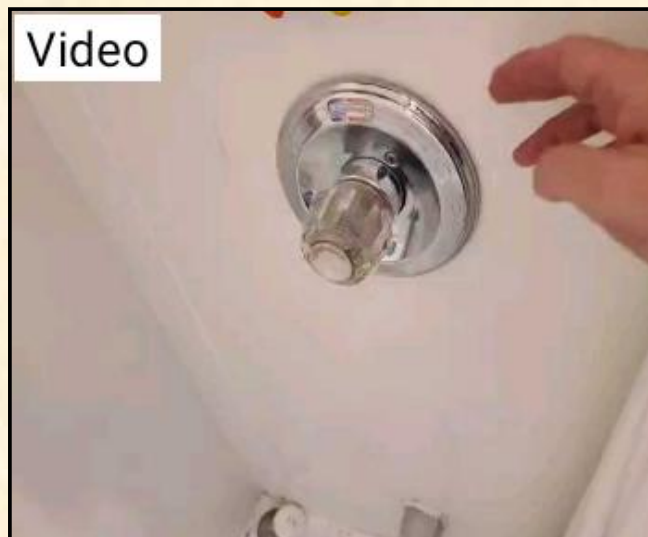
Loose escutcheon plates noted. These should be refastened and caulked to keep water from infiltrating the walls.

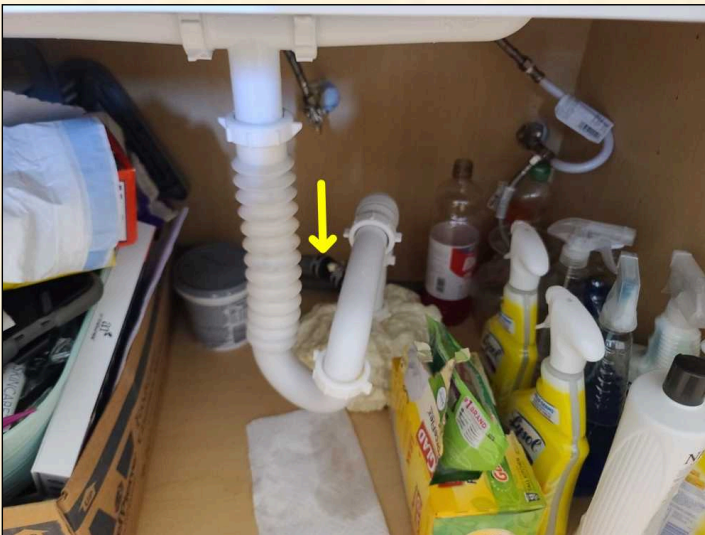
Dishwasher is draining downstream of the trap. This is an improper location and cannot ensure that sewer gases do not enter the appliance.

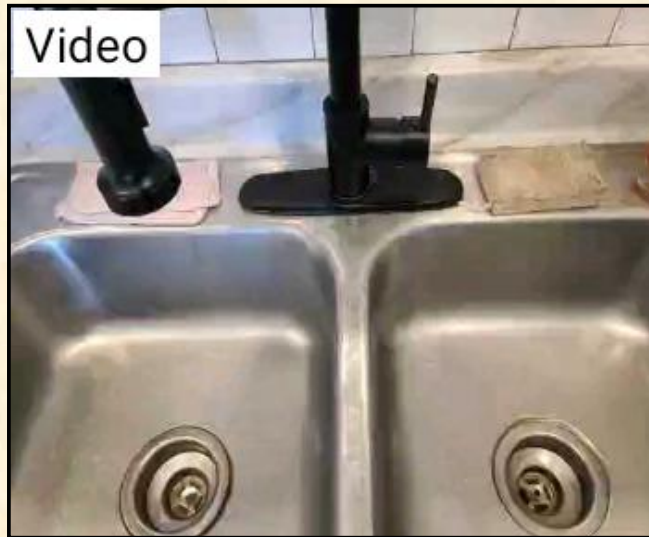
Faucet is loose, suggest securing as necessary.

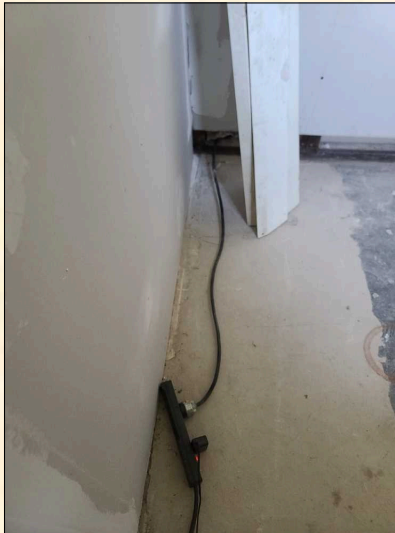
Improper use of extension cord observed. Extension cords should not be permanently installed or be routed through walls, floors or partitions.

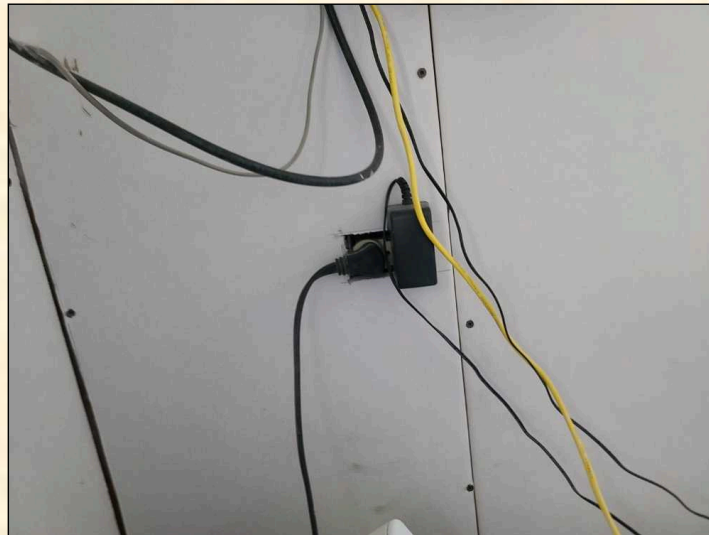
The laundry receptacle should be GFCI protected type.

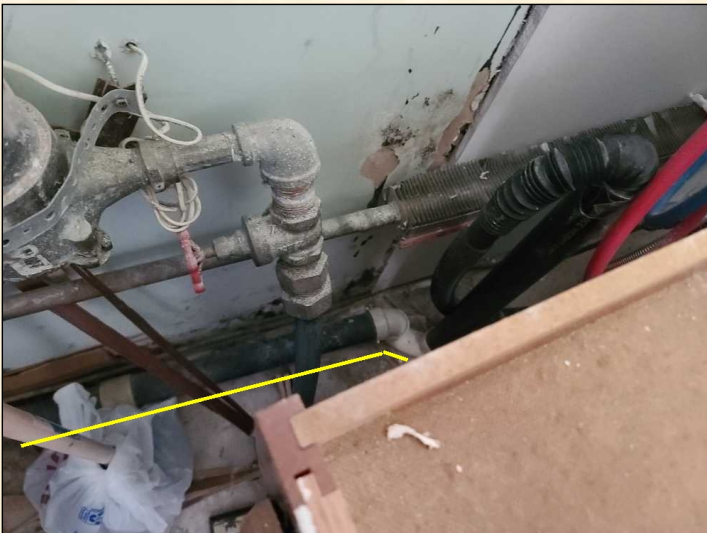
Drain pipe should be a minimum of 6 " off the floor.

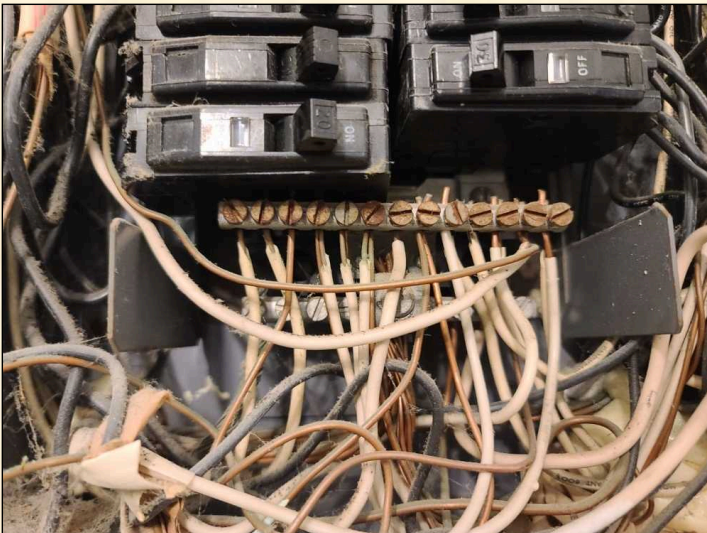
Panel is located in the bathroom. This is not an acceptable location for the panel as it is exposed to high levels of moisture.

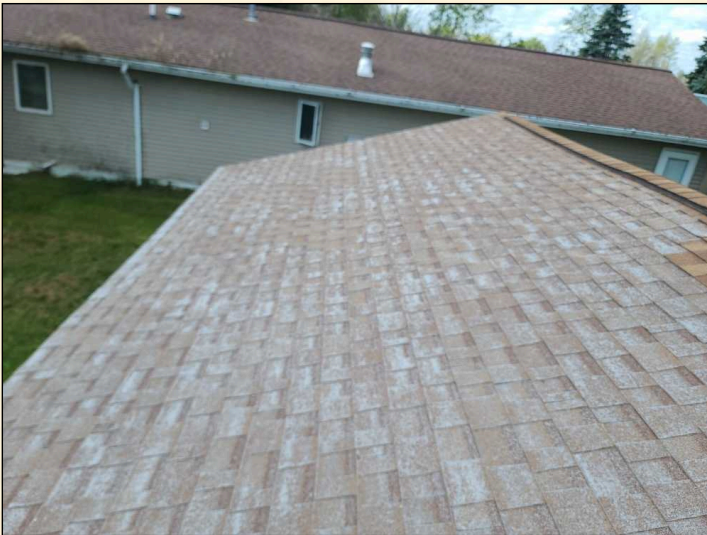
Serviceability of roof is questionable; it should be evaluated and repaired as necessary by a professional roofing contractor.

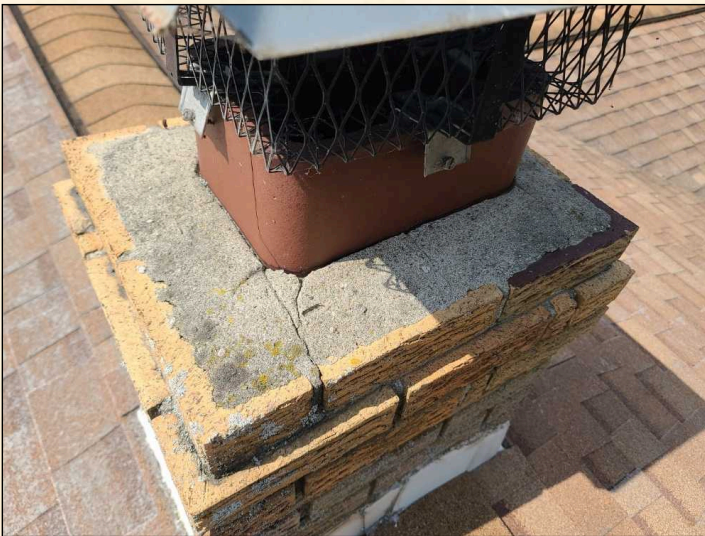
Brick and mortar deterioration observed; repair advised.

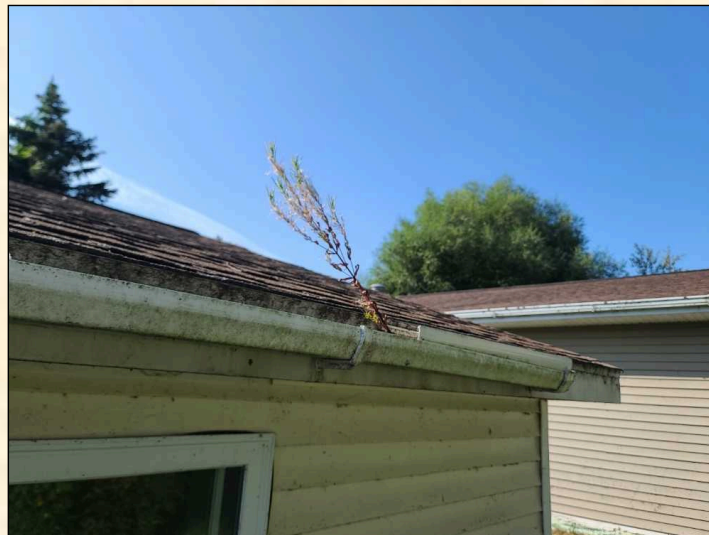
Clean gutters: Significant amounts of debris evident.

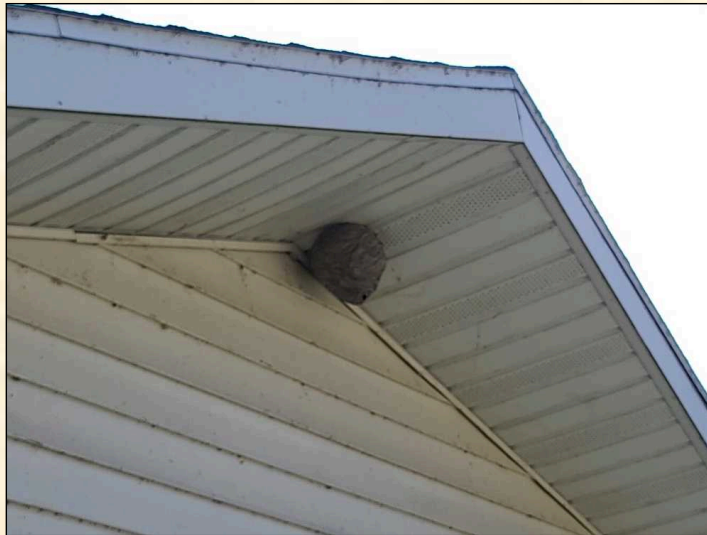
Hornet nest observed on the southwest side. Unable to determine if this is an active nest or not. If anyone in the home is allergic to stings, it is recommended to have this professionally removed.

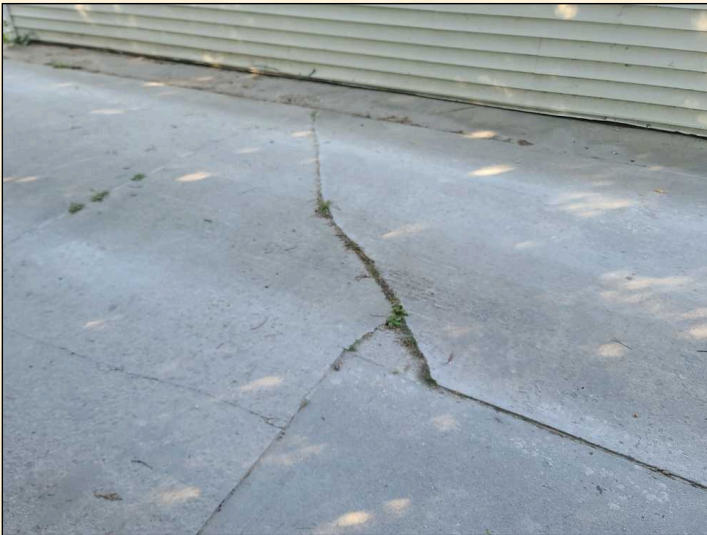
Grounds Driveway and Walkway Condition

• There are numerous areas of damaged concrete surfaces. Concrete replacement is expensive. Recommend a concrete specialist provide an estimate for repair and or replacing.

• Uneven slabs at the driveway. This is a potential tripping hazard. Recommend repair and or replacement of the displaced walks.

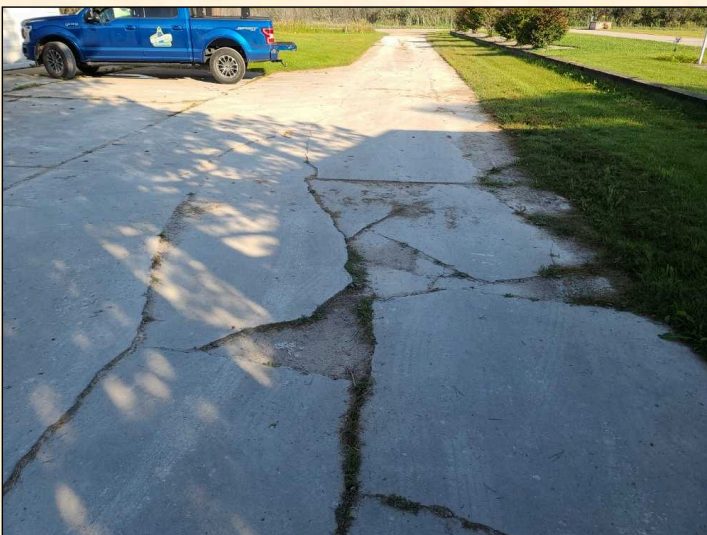
Grounds Driveway and Walkway Condition

There are numerous areas of damaged concrete surfaces. Concrete replacement is expensive. Recommend a concrete specialist provide an estimate for repair and or replacing.

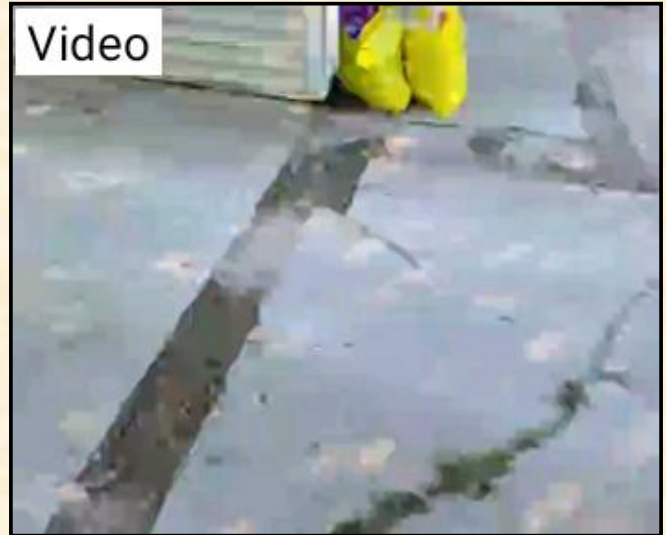
Video  
Uneven slabs at the driveway. This is a potential tripping hazard. Recommend repair and or replacement of the displaced walks.

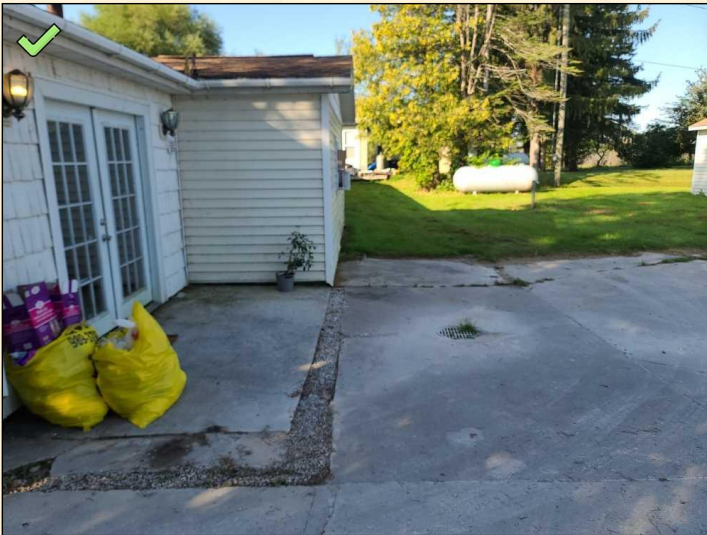
Grounds Grading

- Low and settled grading was observed along the Northwestern (front) and Southwestern (side) areas of the home. Water can intrude affect the foundation.

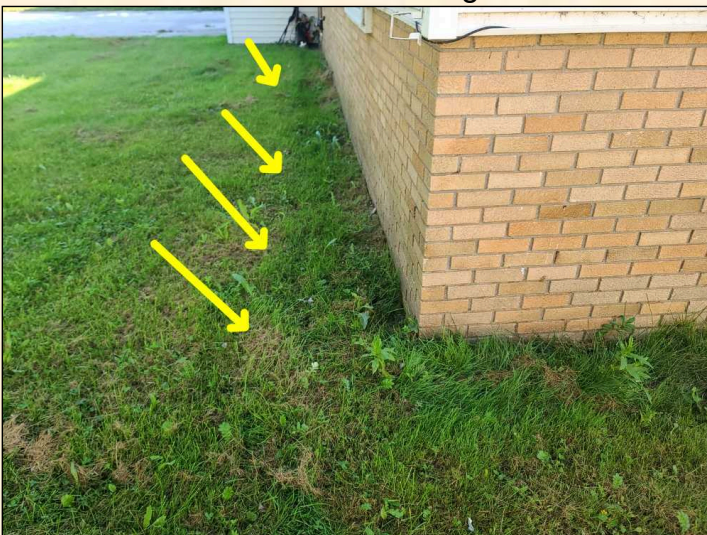
Low and settled grading was observed along the Northwestern (front) and Southwestern (side) areas of the home. Water can intrude affect the foundation.

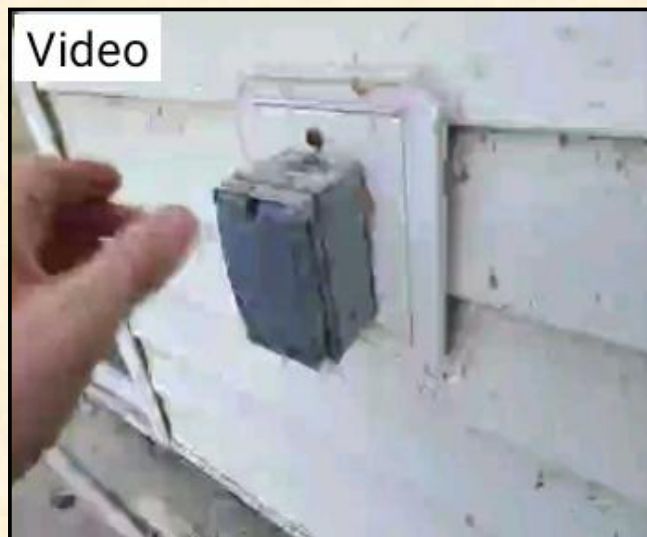
Waterproof outlet cover is loose and needs to be tightened.

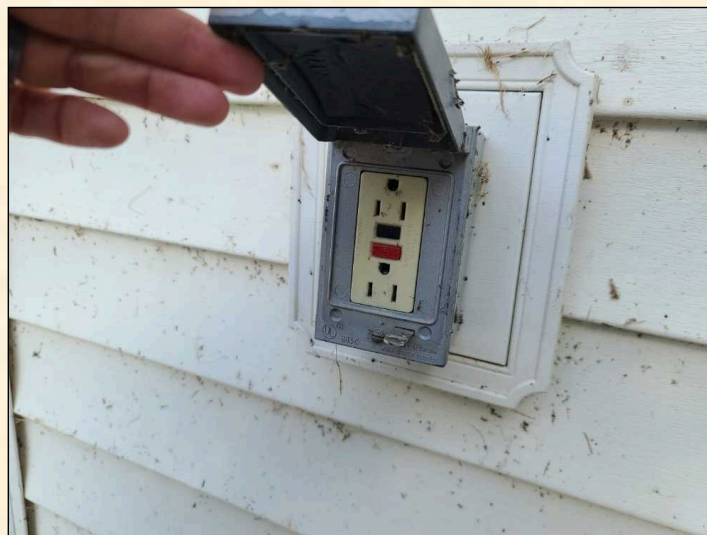
The exterior outlet GFCI did not shut of when tested, have a qualified electrician replace it.

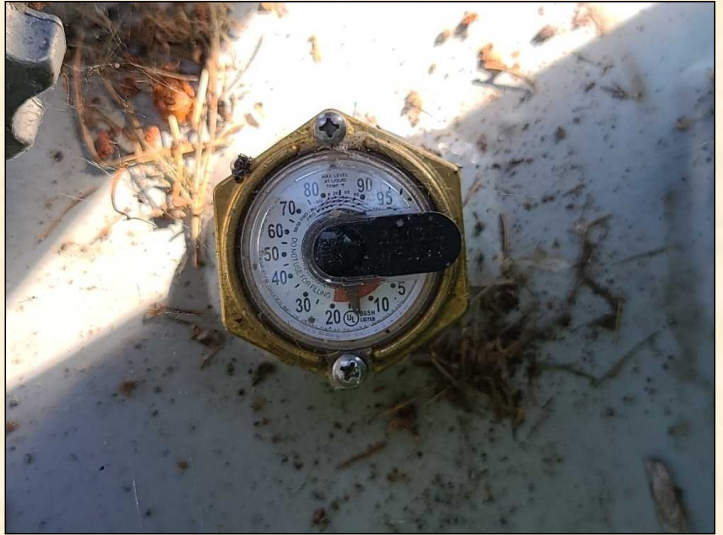
15% propane
